# Rockwell service bulletin

Service Bulletin No. SB-AG-1  
November 30, 1973

## INSPECTION OF VERTICAL FIN STRUCTURE

EFFECTIVITY: MODEL S-2D, SERIAL NO'S 1311D THRU 1379D AND 1381D THRU 1415D

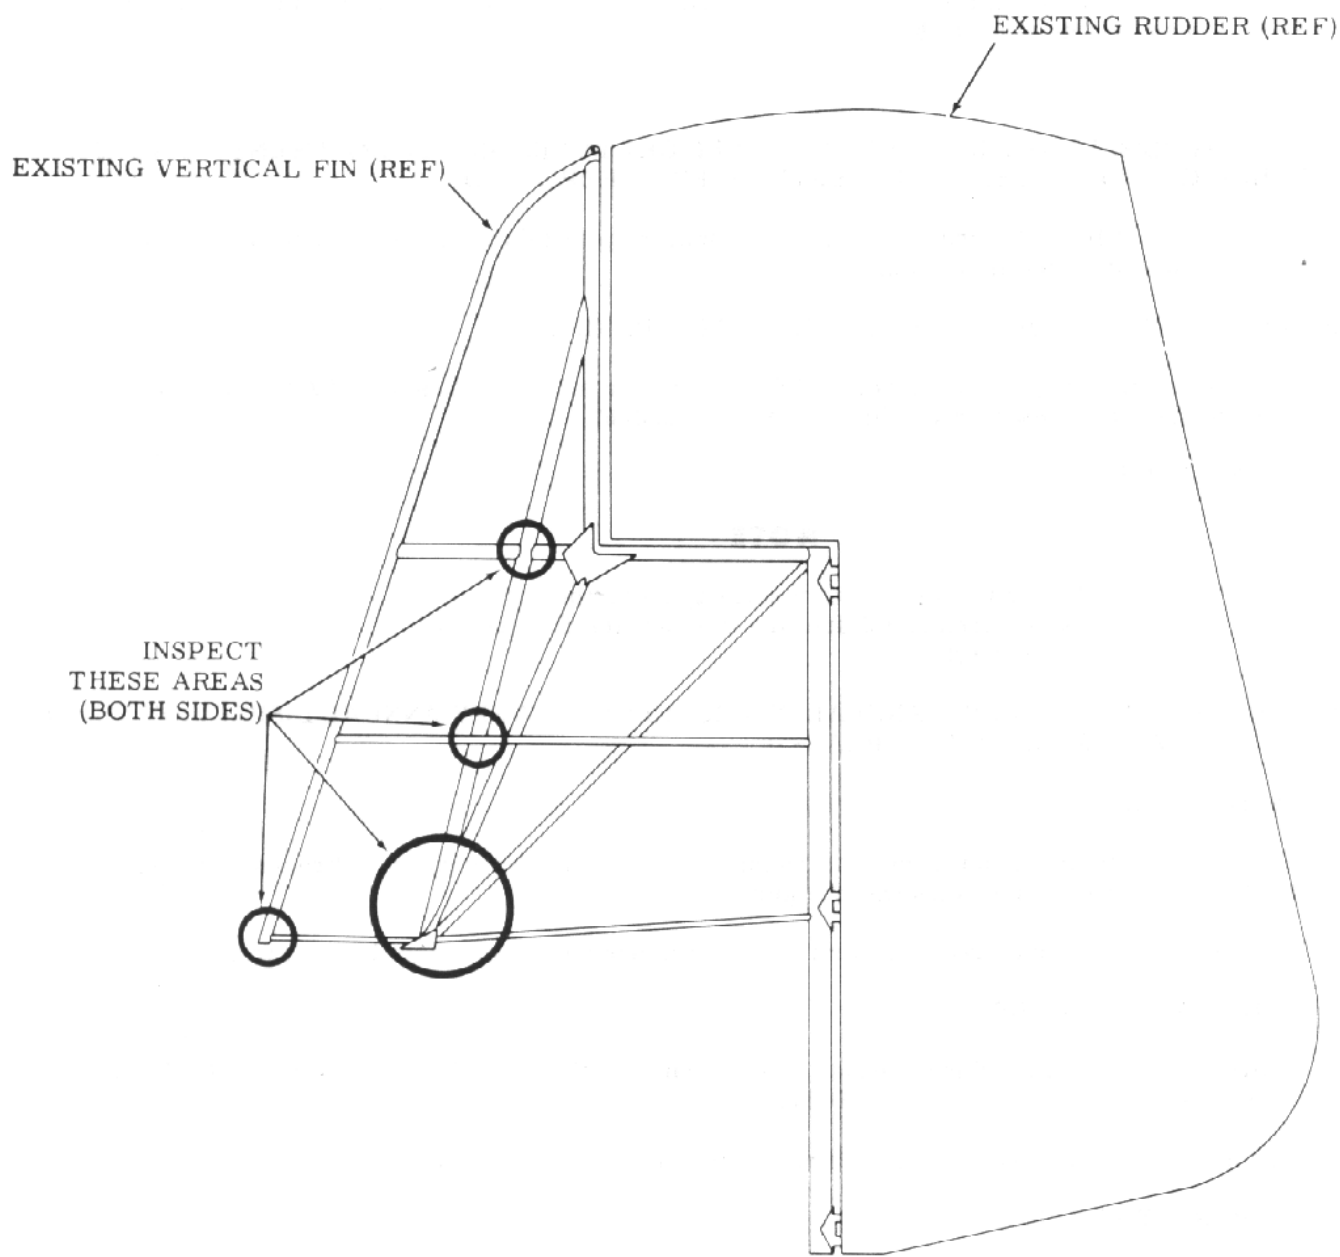
PURPOSE: Service investigation has revealed six (6) vertical fin failures have occurred on both the left and right lower horizontal support tubing of the vertical fin at the leading edge weld cluster and aft of that position at forward vertical fin attach point. This Service Bulletin is being issued to aid the operator during inspection of the vertical fin area to prevent future fin failures.

- a. Visually inspect vertical fin and manually press horizontal support tubing in area shown in Figure 1. to immediately determine if tubing is broken.
- b. If no breaks are detected in tubing, proceed to AIRCRAFT RECORDS.
- c. If breaks are detected in tubing, remove vertical fin and repair in accordance with FAA Advisory Circular AC-43.13-1 or replace with new vertical fin Part No. 5-4030-67.
- d. Proceed to AIRCRAFT RECORDS.

- a. Remove existing vertical fin.
- b. Remove fabric from vertical fin and inspect all welds on vertical fin for cracks or breaks. Particular attention should be directed to areas shown in Figure 1.
- c. If no cracks or breaks are found, recover vertical fin with new fabric and install on aircraft.
- d. Proceed to AIRCRAFT RECORDS.
- e. If cracks or breaks are found in tubing, repair in accordance with FAA Advisory Circular AC 43.13-1 or replace with new vertical fin Part No. 5-4030-67.
- f. If repairs are made, recover vertical fin with new fabric and install on aircraft.
- g. Proceed to AIRCRAFT RECORDS.
