THRUSH AIRCRAFT, LLC.

SERVICE BULLETIN

No. SB-AG-45

FIN SPAR & ATTACH FITTINGS INSPECTION AND UPGRADE

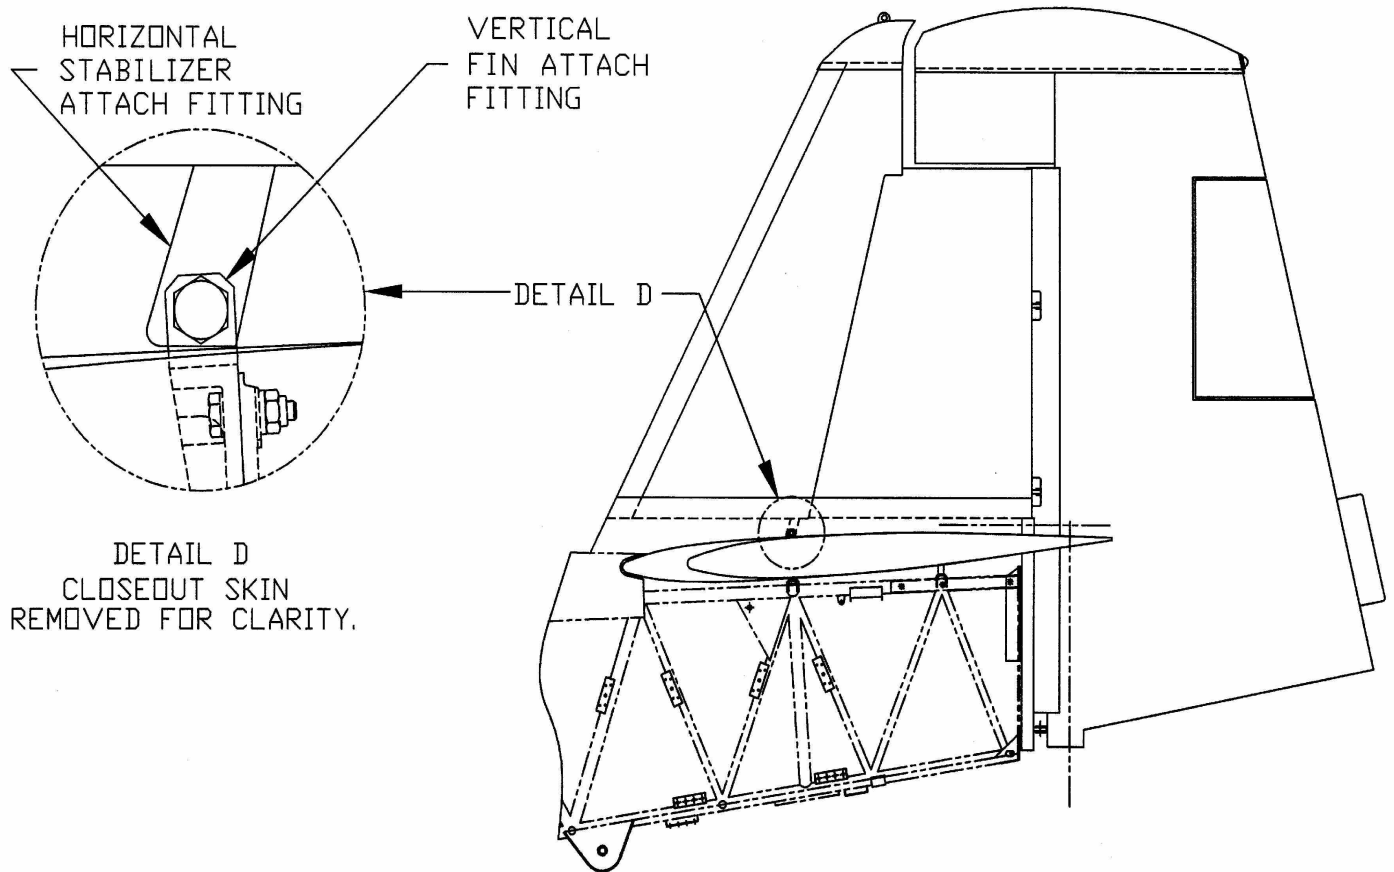
Figure 45-1: Location of Attach Fittings

The vertical stabilizer attach fitting, horizontal stabilizer attach fitting and bolt must be re-inspected every 100 hours thereafter until they are replaced with the 95266-11 vertical fin attach fitting, 95267-5 horizontal stabilizer attach fitting, and larger bolt per SB-AG-45 Rev. D. See Figure 45-1 for the location of these fittings and bolt.

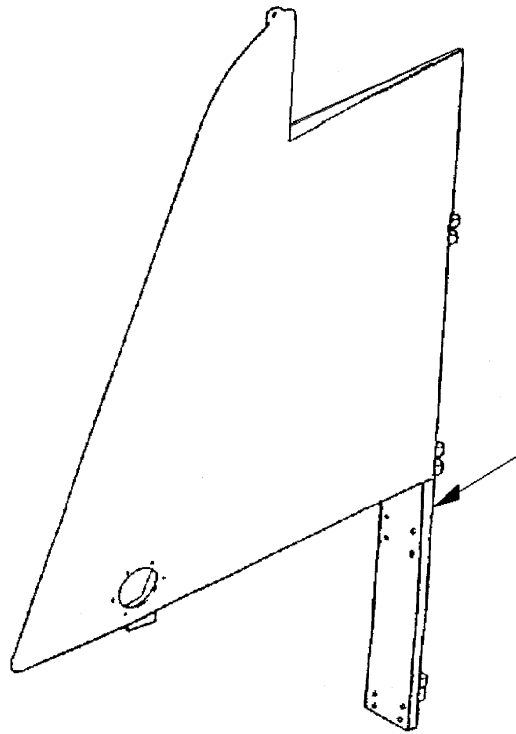
Figure 45-2: Inspect Vertical Fin Spar Assy., Using a 10X magnifier at the Upper Attach Bolts

Remove the rudder from the aircraft. Remove vertical fin fairings, dorsal fin if installed, and the top four bolts attaching the aft vertical stabilizer spar to the fuselage frame. Loosen the bottom four bolts attaching the aft vertical stabilizer spar to the fuselage. While in this area, carefully inspect the vertical fin aft spar for cracks, using a 10X magnifier; especially in the area between the top attach bolts and the center rudder hinge (Ref. Fig. 45-2). Repair, replace and/or refinish the aft spar as necessary.

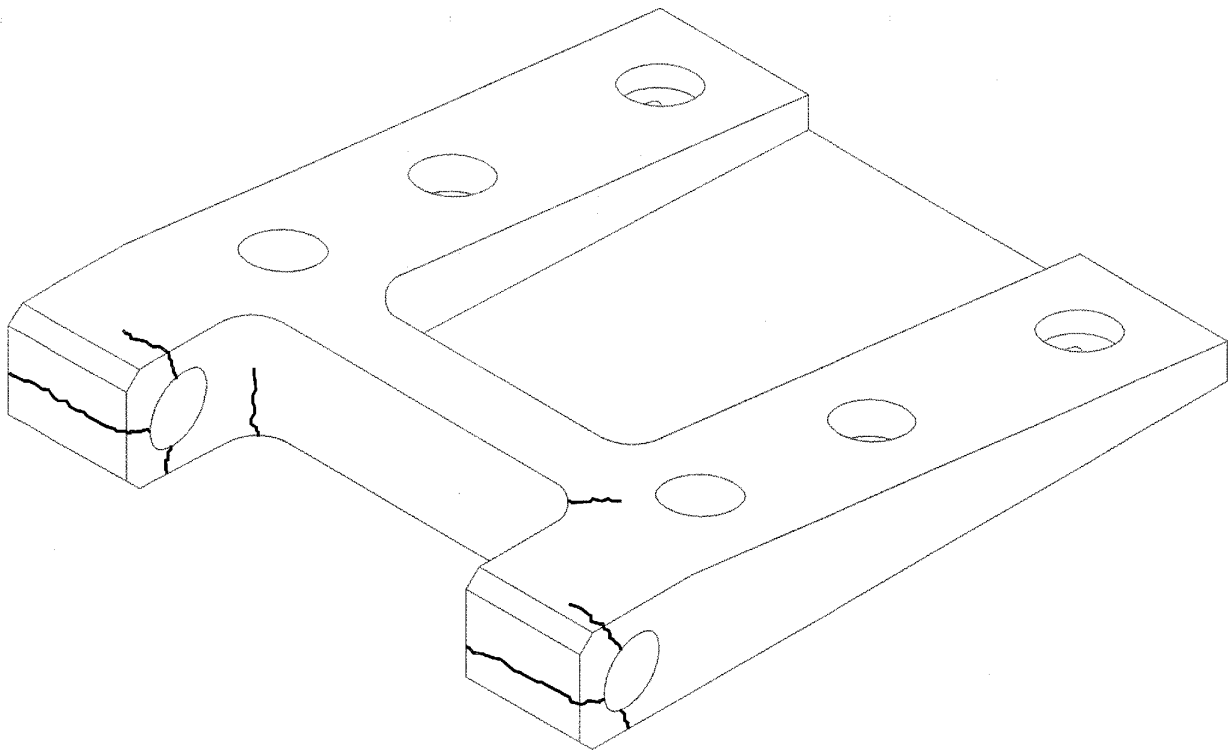
Figure 45-3: Areas of vertical fin attach fitting to be inspected for cracks

Remove the bolt holding the horizontal stabilizer attach fitting to the vertical fin attach fitting on the horizontal stabilizer. **(This terminology may be confusing. The vertical fin attach fitting is on the horizontal stabilizer, and the horizontal stabilizer attach fitting is on the vertical fin.)** Tilt the vertical fin aft until the inner faces of the horizontal stabilizer attach fitting lugs are easily visible. Block the vertical fin in this position with wood blocks. Using a 10X magnifier, visually inspect both lugs of the vertical fin attach fitting on the horizontal stabilizer and the rest of its exposed surfaces for cracks. If the paint is cracked, discolored or bubbled, remove loose paint prior to inspection, as this can hide cracks or corrosion. Also inspect the inside of the holes as much as possible. See Figure 45-3 for areas most suspect for cracks.
