SERVICE BULLETIN

No. SB-AG-78

Revision A: 02/09/2023

Horizontal Stabilizer Attach Channel Repair

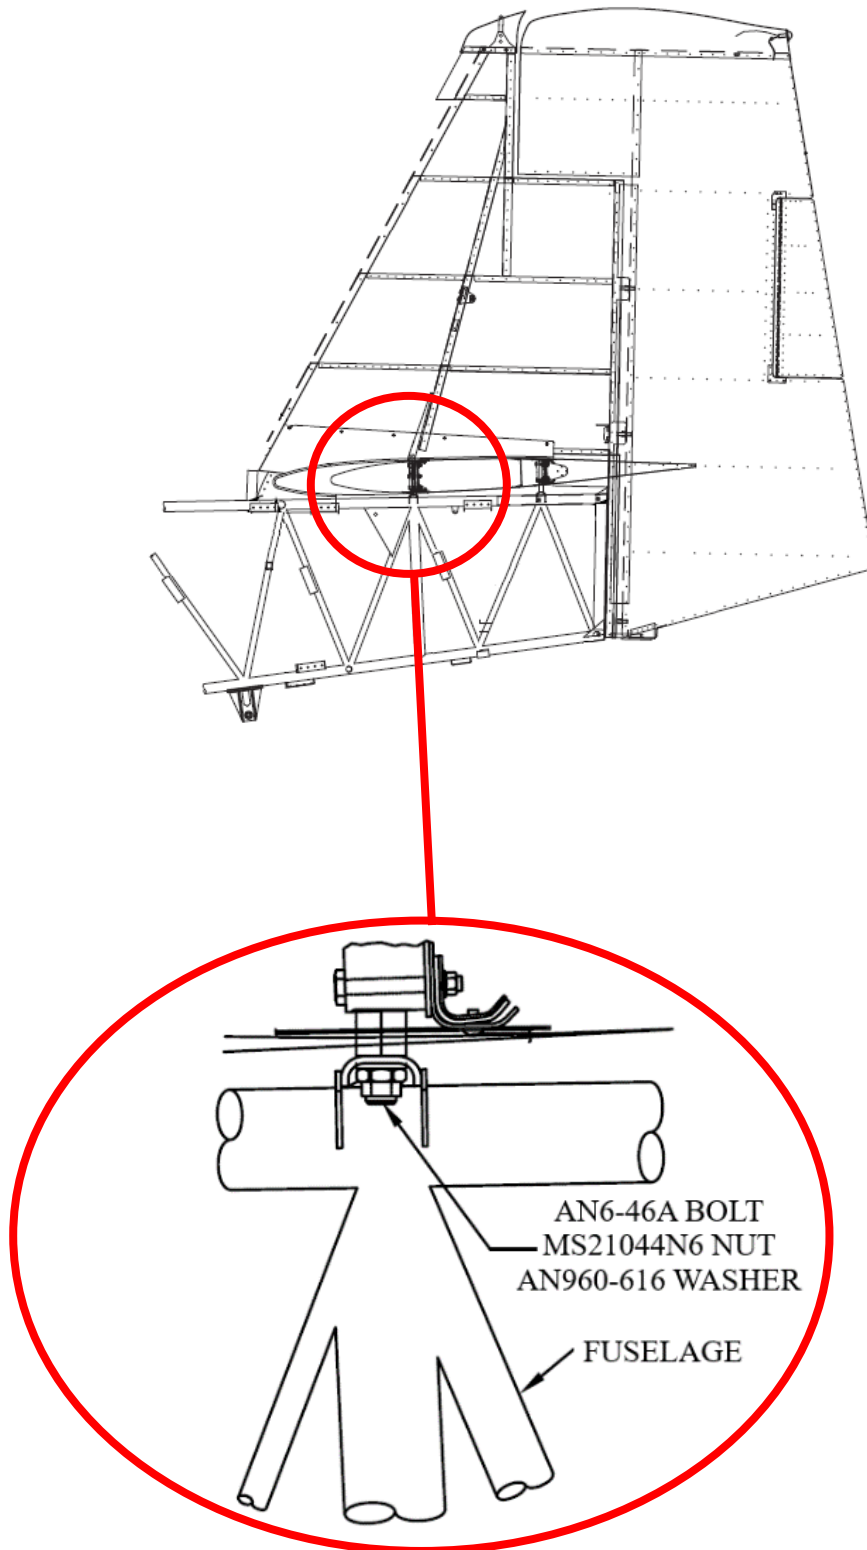
On occasion, damage to P/N 10962-2 “Channel, Stabilizer Attach, Fwd” has been detected during normal periodic inspections of Thrush Models S2R-T34, S2R-H80, S2R-G10, S2R-HGT65, and S2R-T660 aircraft. This Service Bulletin provides instructions and parts to repair this damage by removing and replacing the affected channels with improved parts.

Figure 4. Nut, bolt, washer, and 10962-2 (10962-3 on T660) Channel

1. Prepare and fit welding blankets as required to protect aircraft from weld heat, grinding sparks, and swarf, and to collect and capture as much grinding swarf as possible.
2. Remove any flight control mechanism components that may potentially be contaminated by swarf.
3. Grind or saw to remove 10962-2 Channel (10962-3 on T660) (shown in Figure 4) and its gussets from the airframe longerons, transverse member, and vertical members. Use extreme care to avoid any damage to adjacent airframe members' parent metal. Leave welds .01 to .02 proud of parent metal's surface.

4. Clean area with commercially available acetone and re-inspect to ensure no further damage.
5. Locally remove finish from all areas within 1 inch of joints to be fused, assuring parent metal is undamaged in the process.
