Service Bulletin Number : **SB-AG-34**

## FUSELAGE-WING ATTACH TUBE BEEF-UP

<b>MODELS AFFECTED:</b>	All S2R series aircraft, piston and turbine ; All serial numbers with more than 1000 hours total airframe time.
<b>REASON FOR PUBLICATION:</b>	Field reports and Ayres Repair Station experience with cracks in the 10854-1 tube assembly, below the wing attach angles, near the weld cluster.
<b>COMPLIANCE:</b>	Immediate inspection upon receipt of this bulletin of any airplane with more than 1000 hours total airframe time. Immediate compliance is required before the next flight if any crack (s) exist. If no cracks exist, it is required that the area described be inspected every 100 hours months, whichever first occurs, until such time that the wings are removed. If the wings are removed for any reason, the rework described in this Service Bulletin shall be accomplished prior to the next flight.
<b>BY WHOM WORK WILL BE ACCOMPLISHED:</b>	A & P mechanic or equivalent FAA approved Welding equipment

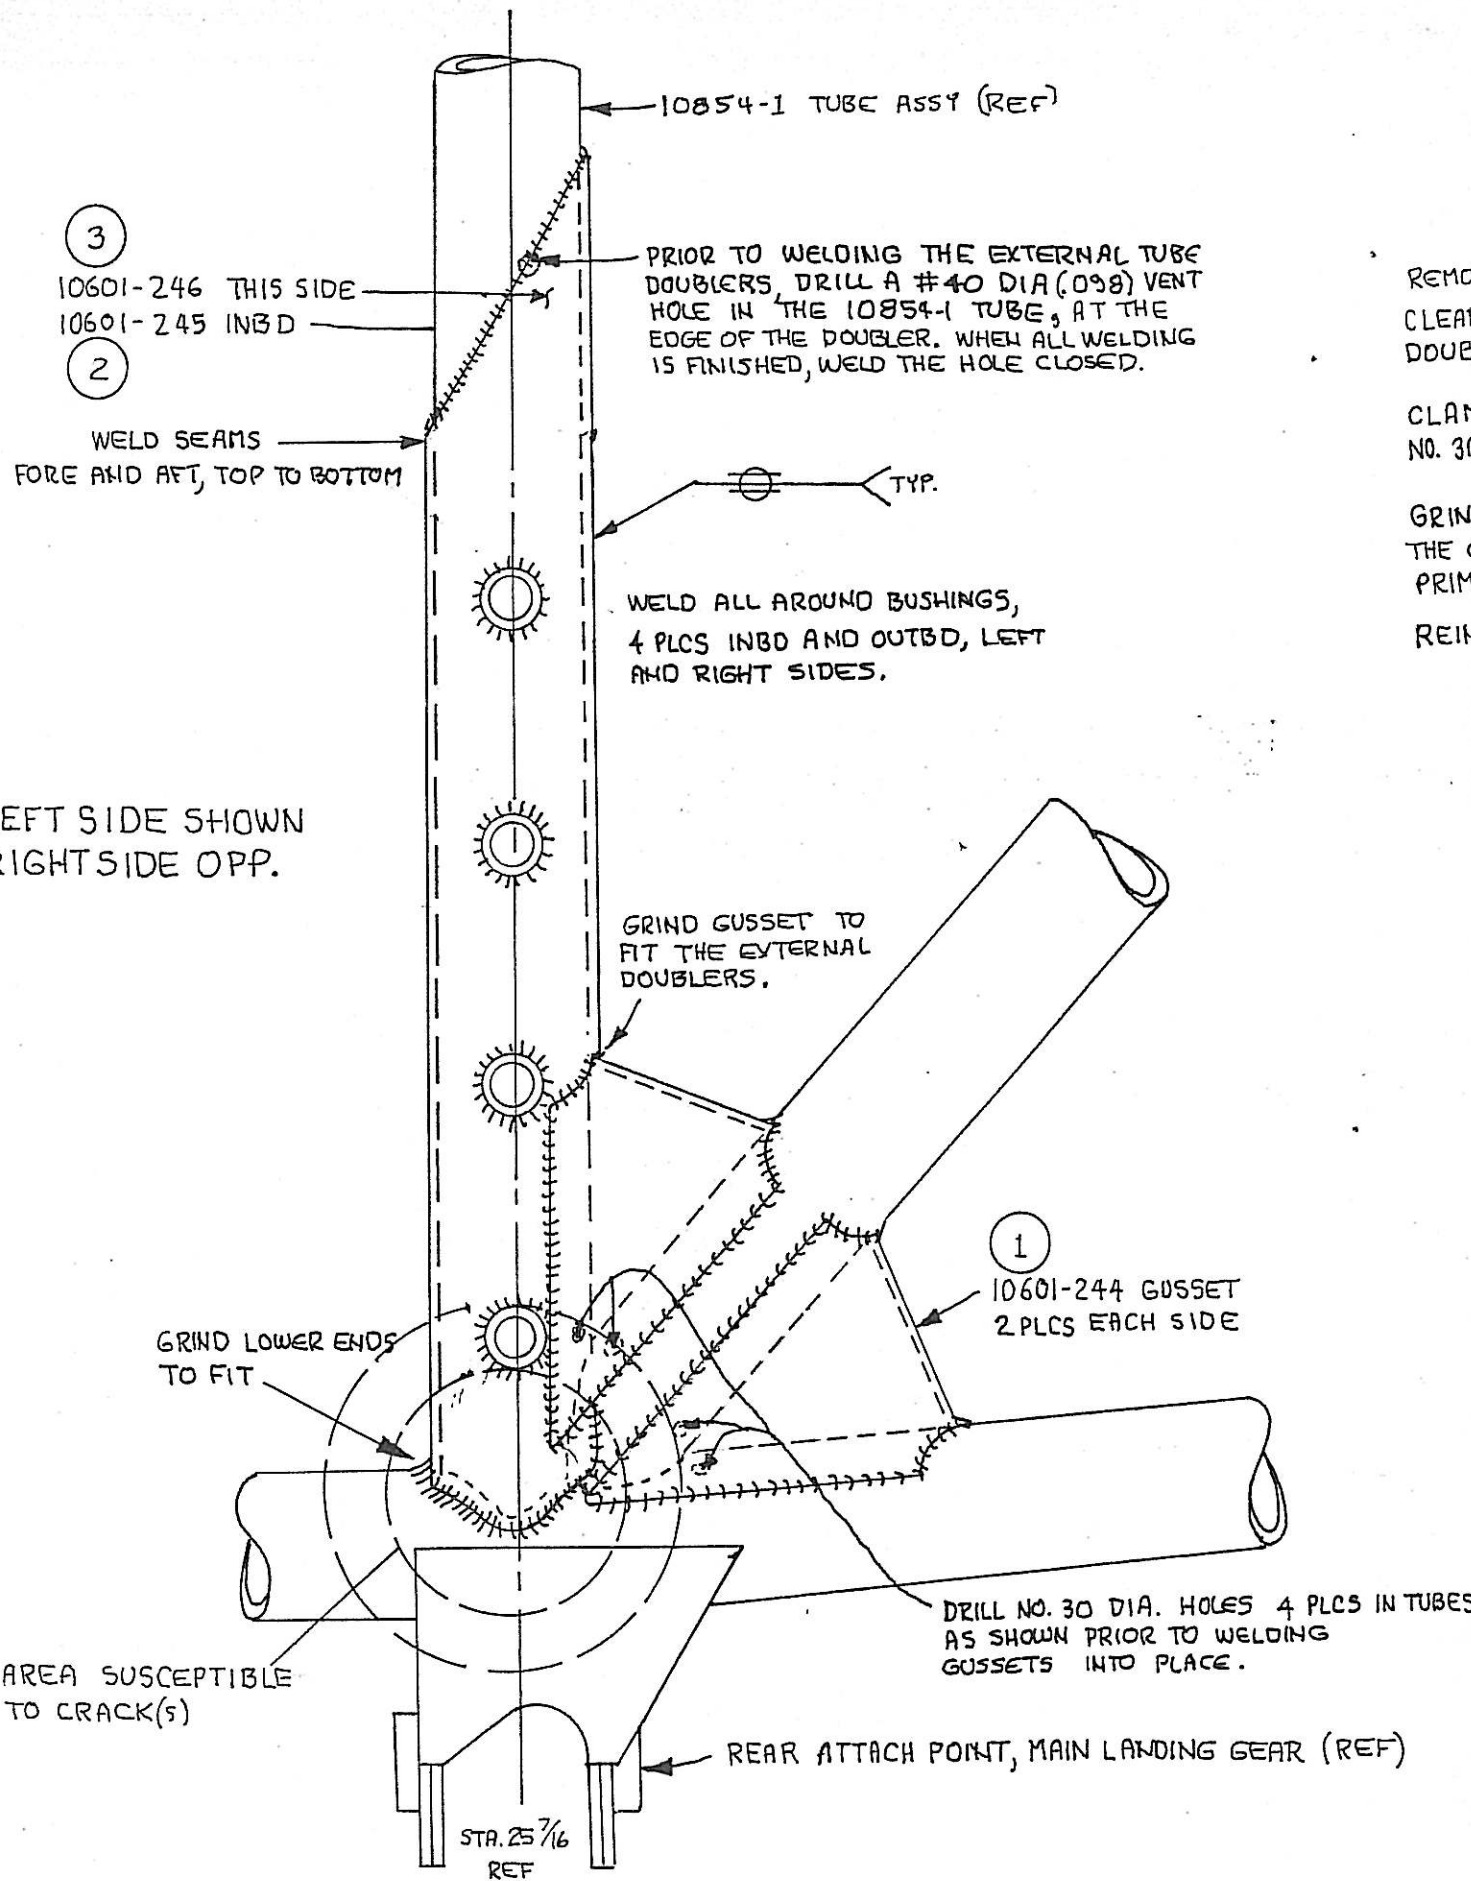
[Drawing of Wing Attach Fitting Beef-Up](#)

1. Remove fuselage side skins to gain access to the wing main spar attach angles, remove landing gear area skins underneath the airplane.
2. With flashlight and mirror, inspect the areas shown in the drawing SB-AG-34-1 in this bulletin. The area is very-difficult to see, so great care must be taken to thoroughly inspect all around the weld cluster. If there is any doubt about the appearance, or suspicion of a crack partially hidden by the wing attach angles, remove them for better access, perform dye penetrant check.
3. If the inspection reveals a crack, compliance is required before the next flight, see drawing SB-AG-34-1.

REMOVE WINGS AND WING ATTACH ANGLES.  
 CLEAN AREA THOROUGHLY, AND REMOVE PAINT FROM AREAS TO BE WELDED. FIT THE EXTERNAL TUBE DOUBLERS AT THE BOTTOM BY GRINDING AS REQD TO MATCH THE CLUSTER TUBES.

CLAMP THE -245 AND -246 IN PLACE AND DRILL #40 DIA VENT HOLE AS SHOWN. DRILL THE 4 EACH NO. 30 DIA. VENT HOLES IN THE CLUSTER TUBES AS SHOWN. WELD THE DOUBLERS COMPLETELY, EXCEPT UPPER VENT.

GRIND AND FIT THE -244 GUSSET AT THE FRONT TO MATCH THE EXTERNAL DOUBLER RADIUS. WELD THE GUSSETS INTO PLACE. WELD THE VENT HOLE AT TOP CLOSED. WIREBRUSH, SAND AND CLEAN THE REPAIR. PRIME AND PAINT.

REINSTALL WINGS, RECORD COMPLIANCE IN AIRCRAFT LOG BOOKS.
