THRUSH AIRCRAFT, INC.

SERVICE BULLETIN

No. SB-AG-49

SEAT SUPPORT BRACKET INSPECTION AND REPAIR

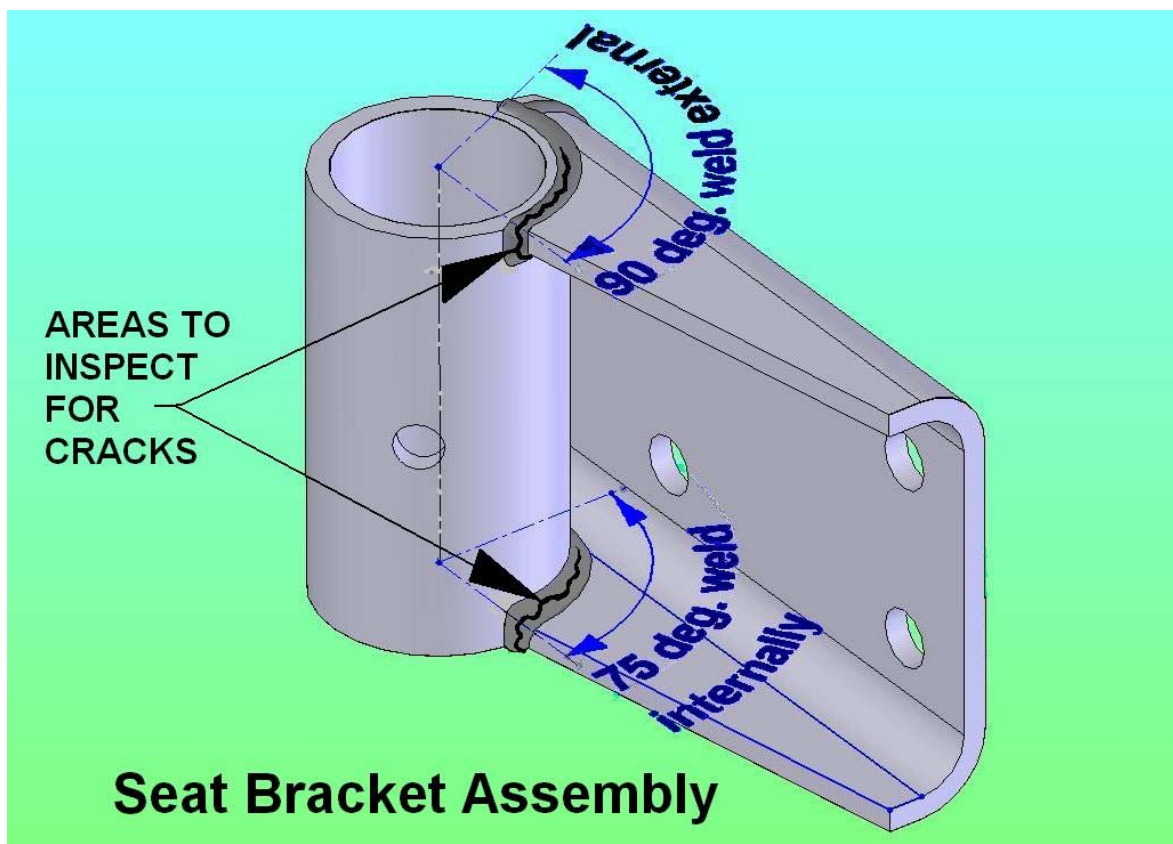
Recently on our production line two P/N 10892-8 seat support bracket assemblies were found to be cracked in a weld. The cause of the crack was determined to be that the weld did not go all the way around the part, as the drawing specified. Cracking of this part in service could lead to its failure, which would mean the seat is attached to the rails in only 3 of the 4 designed locations. The extra stress on the remaining brackets could cause them to crack and fail sequentially until the seat is no longer attached to the aircraft. A loose pilot's seat could cause loss of control of the airplane and potentially a crash.

Inspection of the 10892 -8 seat bracket assemblies must be accomplished immediately upon receipt or downloading of this service bulletin. The 10892-8 bracket assembly, which holds the seat to the rails at the top, is shown below. While accomplishing this inspection, also inspect the lower seat bracket assemblies, which are constructed similarly. Inspect as follows:

1. The outside joints, as seen at the top of the illustration below, must not be cracked and should be welded over a 90 degree arc minimum.
2. The inside joints (as seen at the lower crack in the illustration) between the tube and the bracket must not be cracked and should be welded around 75 degrees minimum.

3. If the inside joints are not welded, or are not welded over at least a 75 degree arc, the bracket assembly must be re-inspected every 100 hours thereafter until it is replaced with a new one or it is removed and welded properly.
4. If a weld joint is cracked, the bracket must be replaced or repaired **before further flight**.

3. Re-weld the joint, using TIG or acetylene method and a 4130 steel welding rod. Start at the inner-most point in the joint and working out to the outside edge. The fillet weld should be a minimum of 1/8" wide and 1/16" high, with good penetration and no blow-holes.
