THRUSH AIRCRAFT, INC.

SERVICE BULLETIN

No. SB-AG-51

WIRE BUNDLE SHORT CIRCUIT

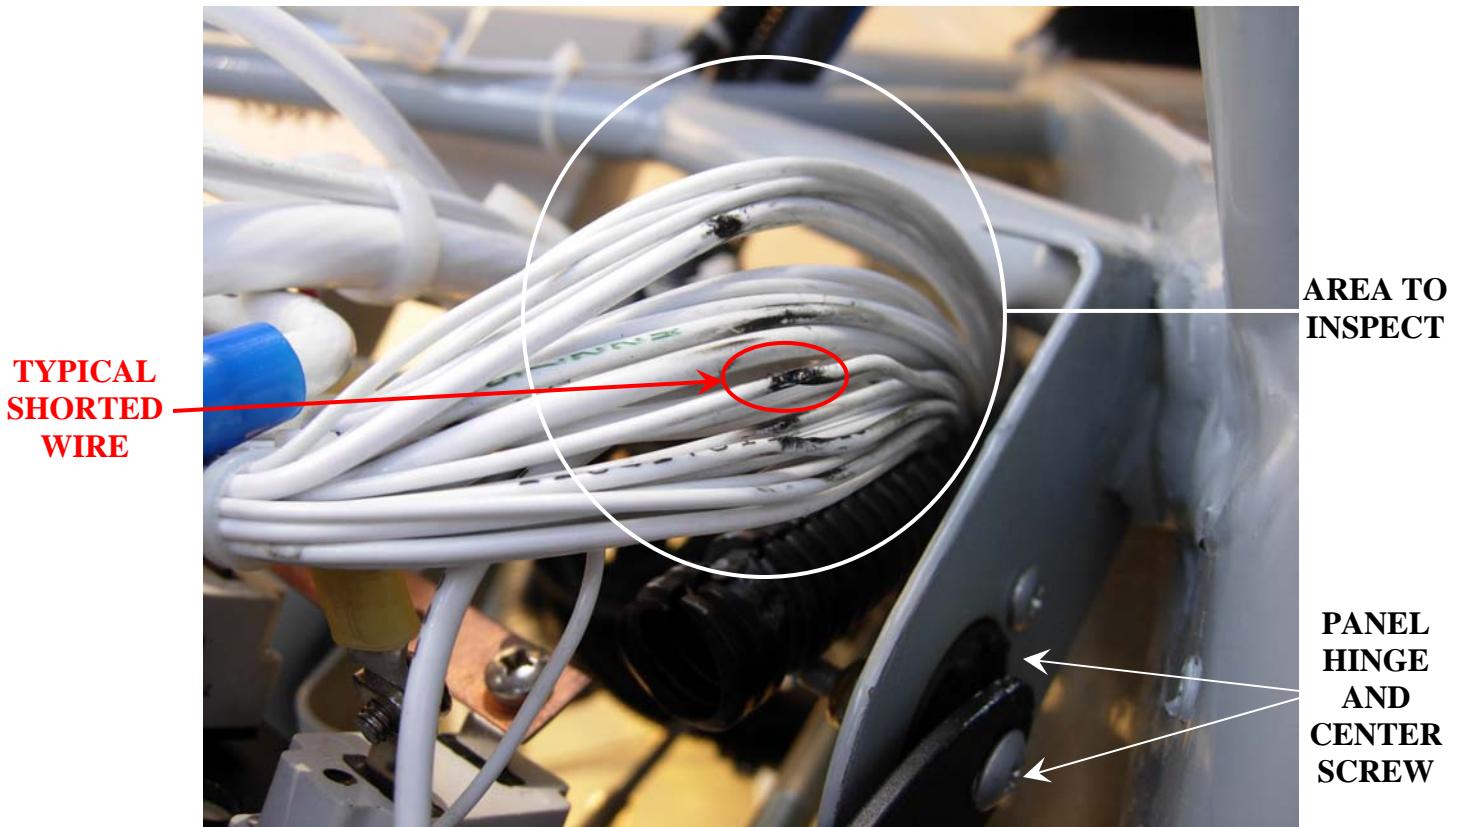
A case has been reported of the wire bundle to the lower right instrument panel chafing on the hinge screw, causing several short circuits (see Figures 51-1 & 51-2). No discernable smoke in the cockpit resulted, but the flap control circuit breaker popped intermittently, removing the ability to move the flaps. A number of other symptoms could occur, depending on which wires short, but none of them would cause a safety-of-flight concern. Several short circuits at the same time could, however, be disconcerting to a pilot not aware of the potential problem, especially if there was discernable smoke in the cockpit.

FIGURE 51-1: Shorted Wires Behind Lower Right Panel
View looking forward and inboard

Visually inspect wires and wire bundles in the vicinity of the outboard panel hinge (see Figures 51-1 through 51-5). Shorted wires will be obvious, similar to figures 51-1 & 51-2. Inspect for evidence of chafing of wires even if there are no short circuits. Rotate the panel back to the upright position and measure how close the wire bundle is to the center hinge screw. Check to see that the wire bundle is well tied off, while leaving enough slack to enable panel rotation.

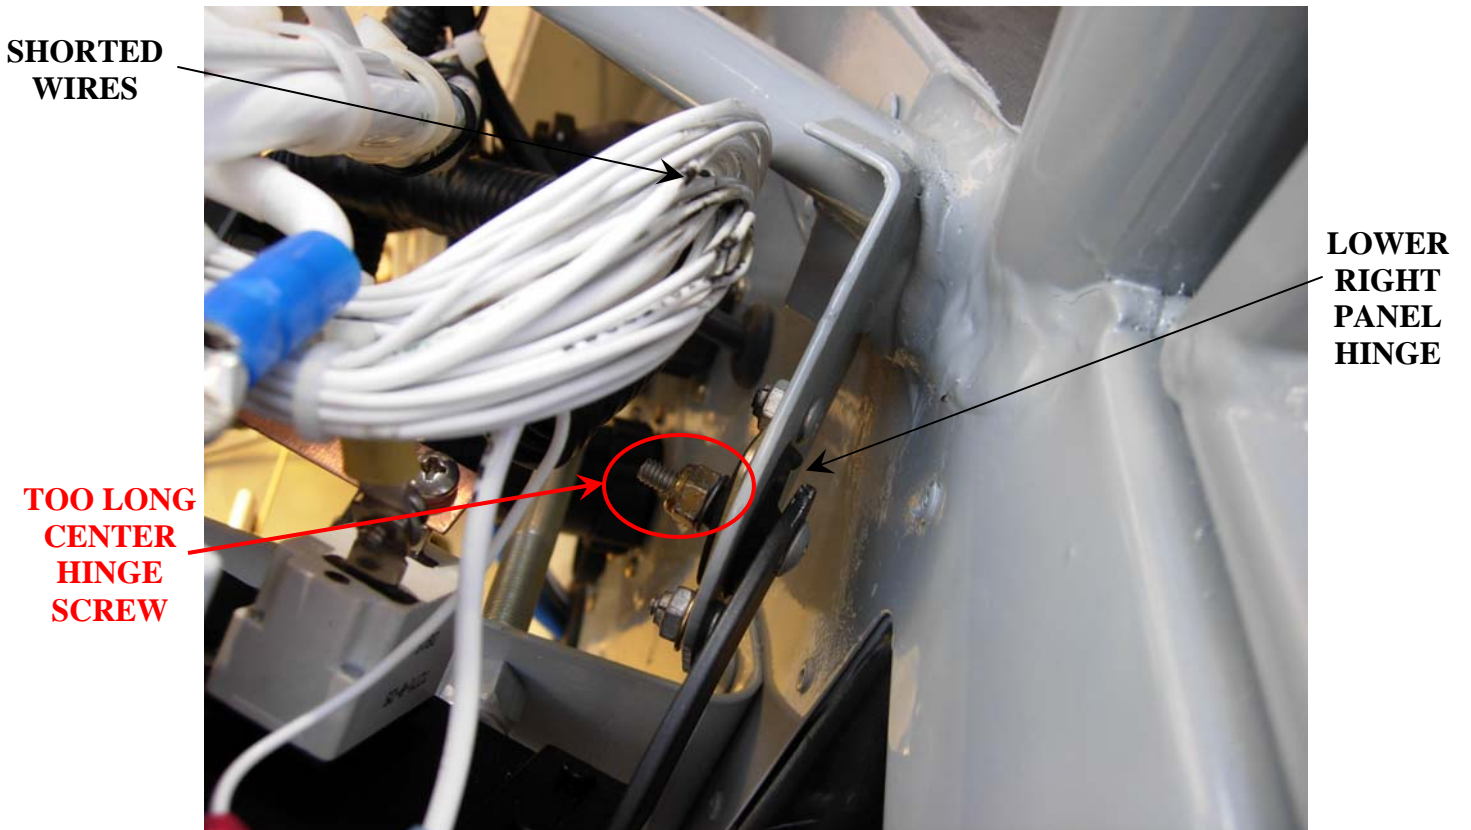
FIGURE 51-2: Too Long Hinge Screw that Shorted Wires

If on either side there are no shorts or significant wire chafing, the wire bundles are well tied-off, and no wires come closer than 1/2" to the center hinge screw, then the inspection is complete. To complete compliance with Service Bulletin SB-AG-51 this inspection must be recorded in the airplane maintenance log and the compliance record mailed or transmitted back to Thrush Aircraft, Inc. If any of the above requirements is not met, repair per the REPAIR section will be necessary in order to complete the Service Bulletin.

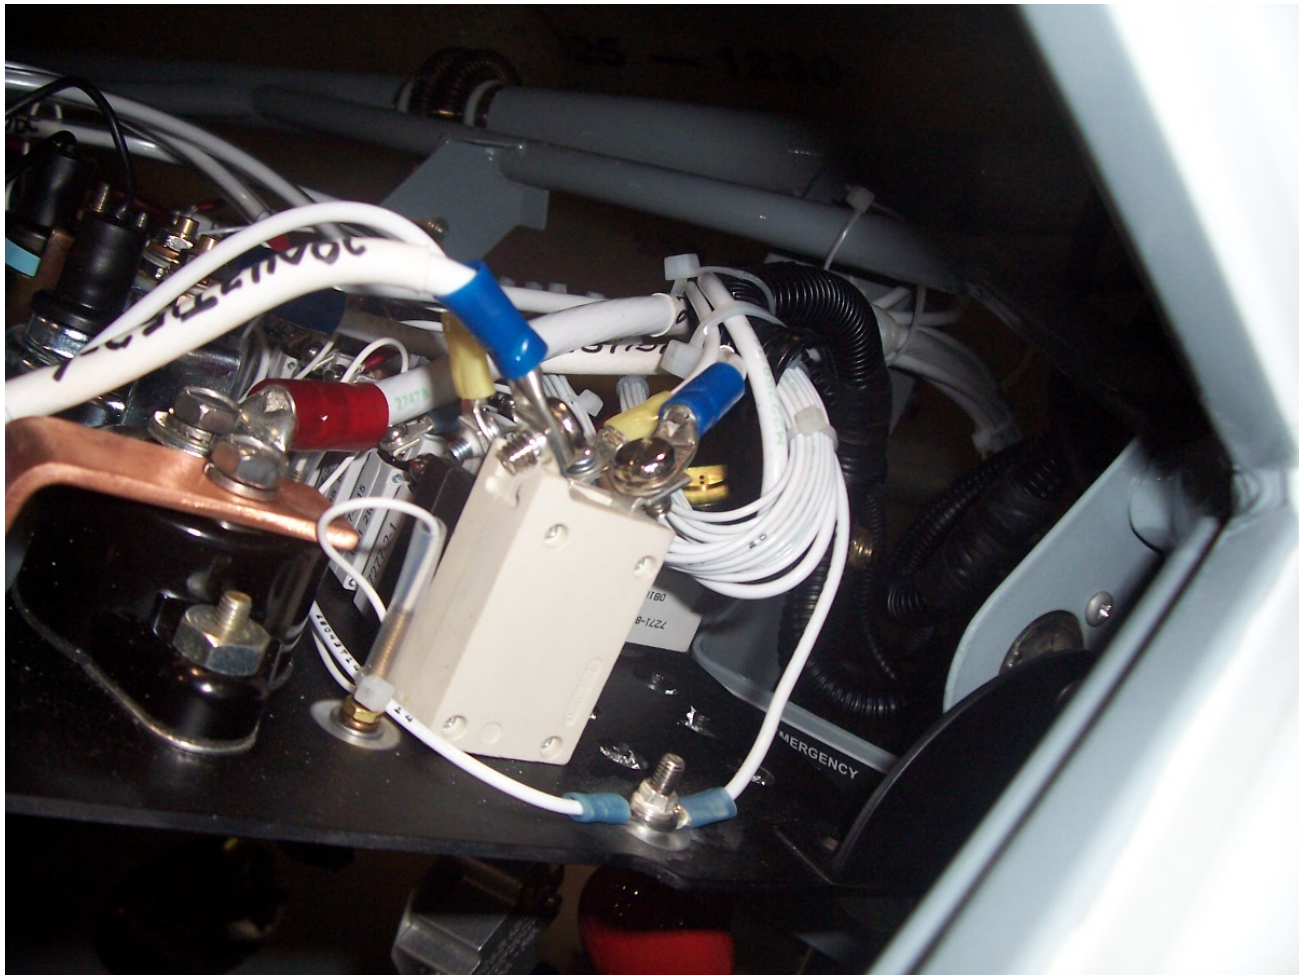
FIGURE 51-5: Properly Tied-off Wire Bundle
