THRUSH AIRCRAFT, INC.

SERVICE BULLETIN

No. SB-AG-53

S2R-T660 RUDDER **INSPECTION**

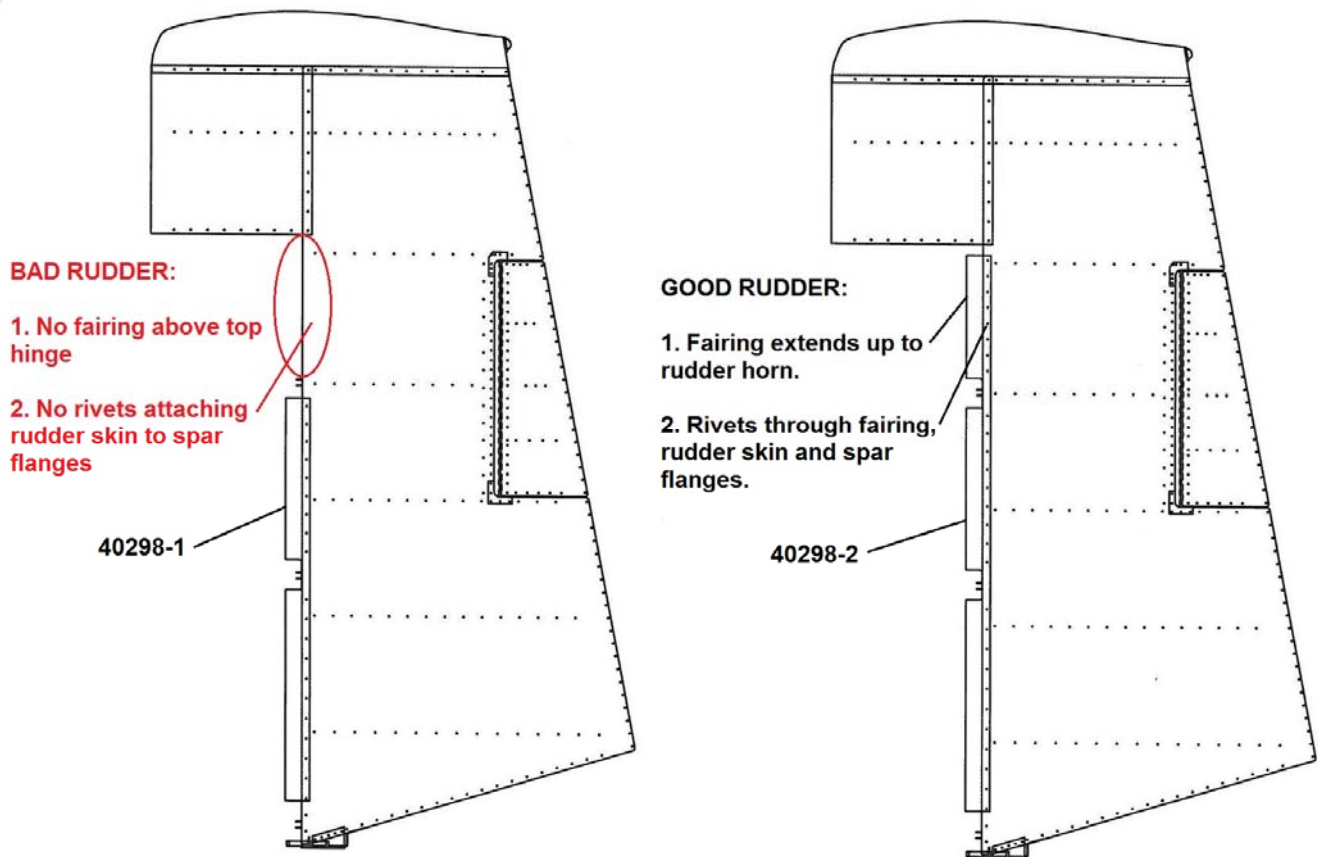
Figure 53-1: Comparison of Good & Bad Rudder

The cause of this failure was a manufacturing error in that the wrong fairing was installed on the front of the rudder spar (see Figure 53-1). The correct fairing extends all the way up to the rudder horn, whereas the one installed stopped at the top hinge. This error was compounded by the fact that no rivets were installed to attach the rudder skin to the rudder spar flanges between the top hinge and the rudder horn. This portion of the rudder spar was therefore much weaker than it should have been, and was inadequate in the long run to sustain the twisting force applied to it by the rudder horn every time the rudder was deflected significantly.

Such a scenario is easy to prevent because a simple visual inspection will determine whether or not the rudder has the same condition as described above. If the rudder is configured similar to what is described above and is shown in Figure 53-1, the airplane should not be flown again until the condition is corrected.

Note: The rudder illustrated is the 95265-17 “tall” rudder, having an additional bay at the top of the horn. The 95265-15 rudder has a one bay horn, but the area in question is the same.

Prior to further flight the rudder must be inspected at the spar between the upper hinge and the aerodynamic balance (horn) to ensure that it has the 40298-2 fairing and that it is properly installed (see Figure 53-1).

1. If the rudder does not have the 40298-2 fairing installed properly, replace the rudder assembly with a new 95265-15 or 17 rudder, as applicable. It is not sufficient to just install the proper fairing, since the rudder structure may have already sustained significant damage.
