# SERVICE BULLETIN

## No. SB-AG-58

Revision A 10/15/2015

ELEVATOR, RUDDER, AND AILERON CONTROL SYSTEMS  
INSPECTION AND HARDWARE REPLACEMENT TO  
INCORPORATE CASTELLATED NUTS IN JOINTS SUBJECT  
TO ROTATION

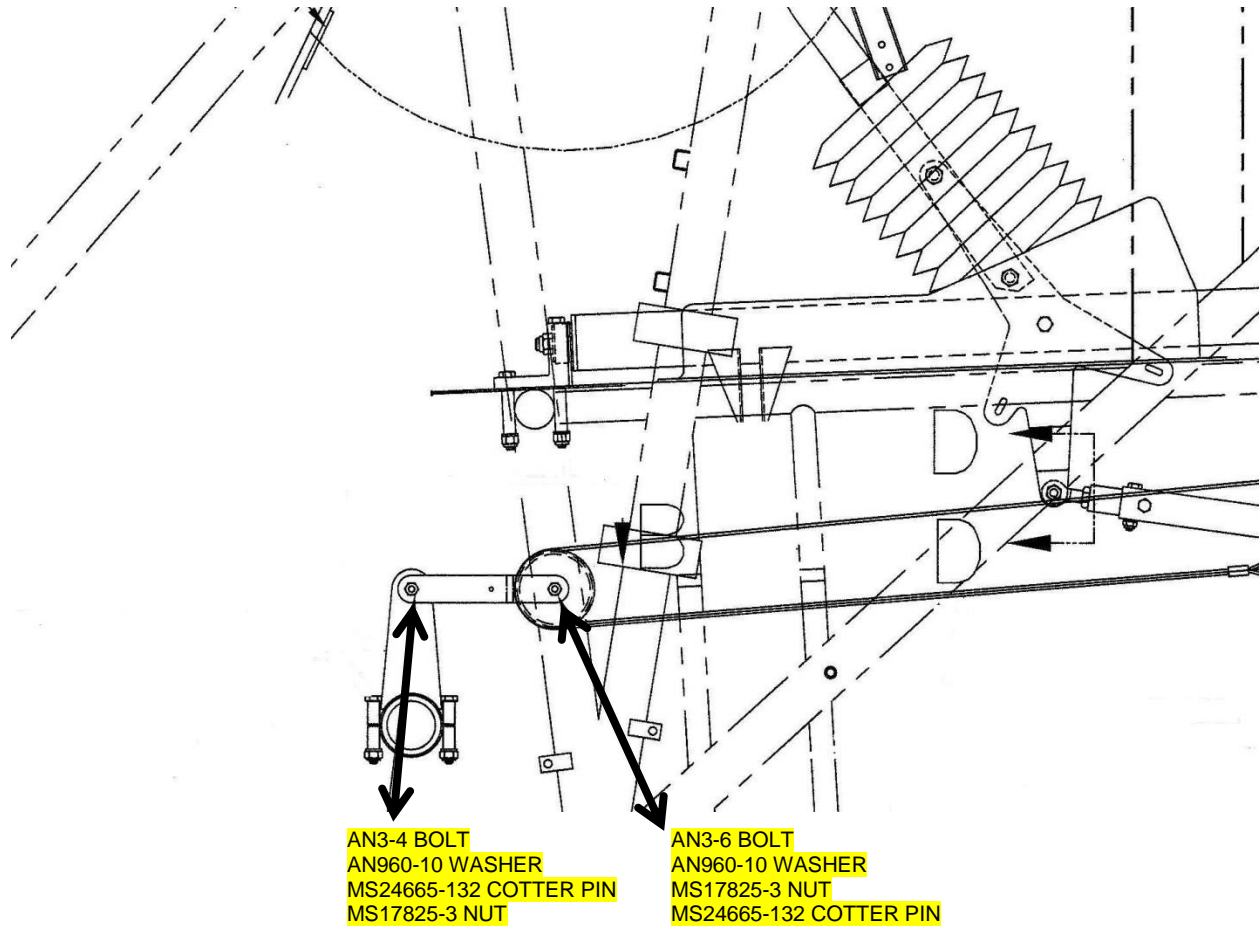
**FIGURE 58-1**

**VIEW LOOKING INBOARD FROM L/H SIDE FWD OF FUSELAGE  
TYPICAL ALL SINGLE COCKPIT MODELS EXCEPT H80**

Inspect the applicable hardware using the diagrams below and replace existing hardware if it does not conform to the highlighted information.

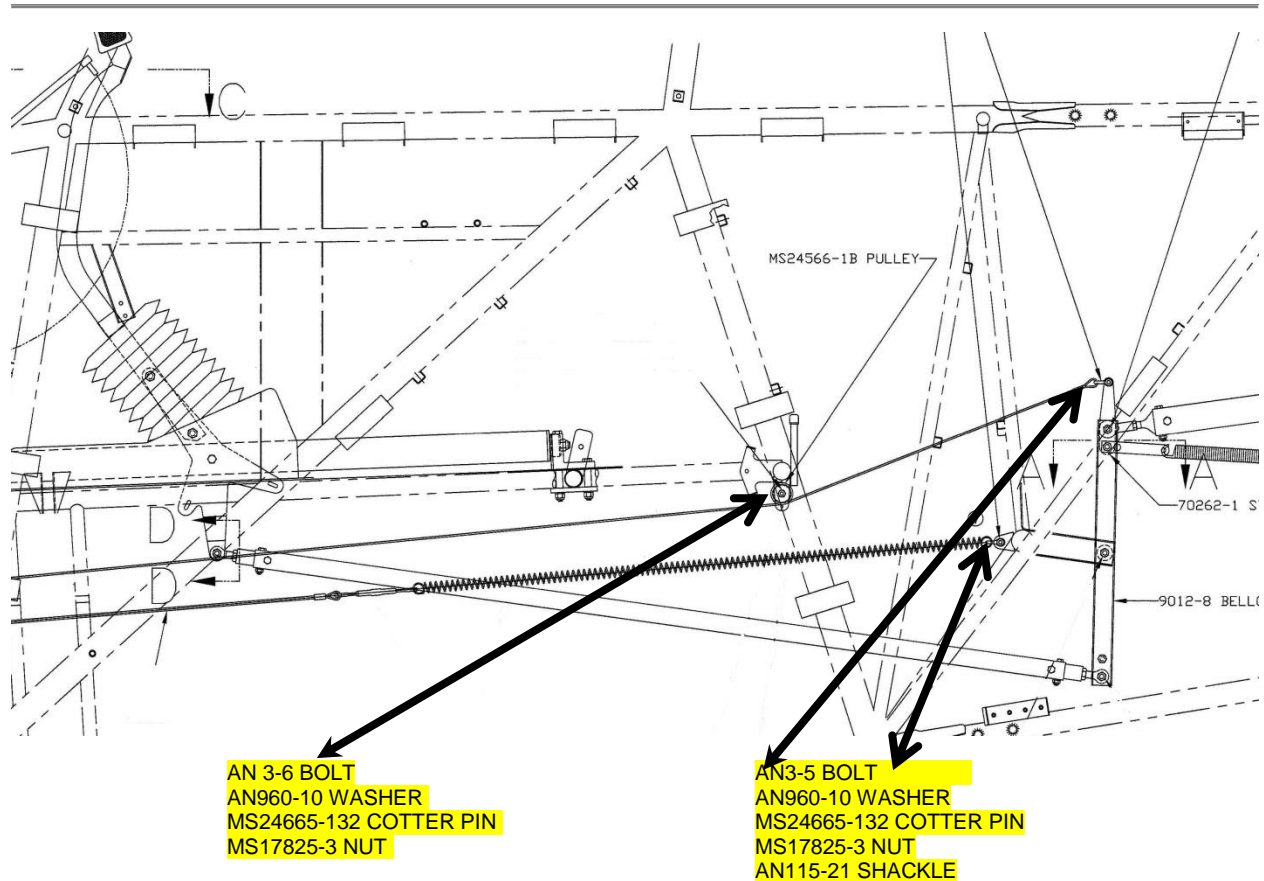
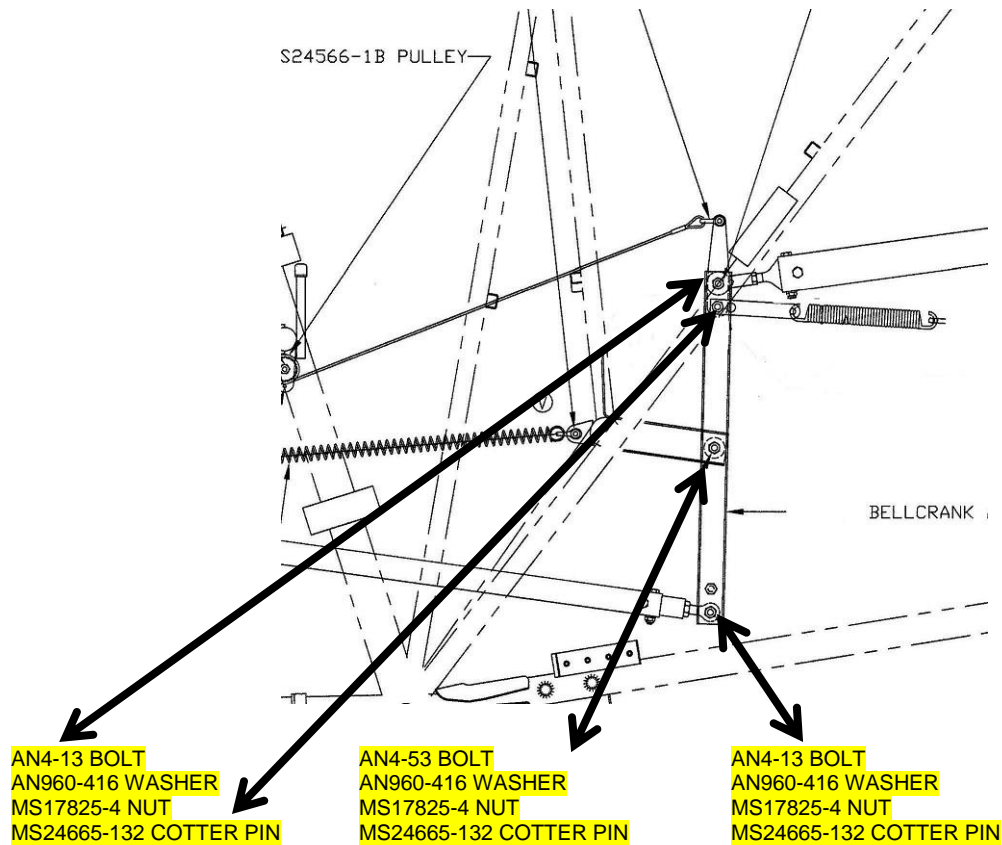
**FIGURE 58-2**

**VIEW LOOKING INBOARD FROM L/H SIDE CENTER OF FUSELAGE  
TYPICAL ALL SINGLE COCKPIT MODELS EXCEPT H80**

- AN3-5 BOLT
- AN960-10 WASHER
- MS17825-3 NUT
- MA24665-132 COTTER PIN
- AN115-21 SHACKLE

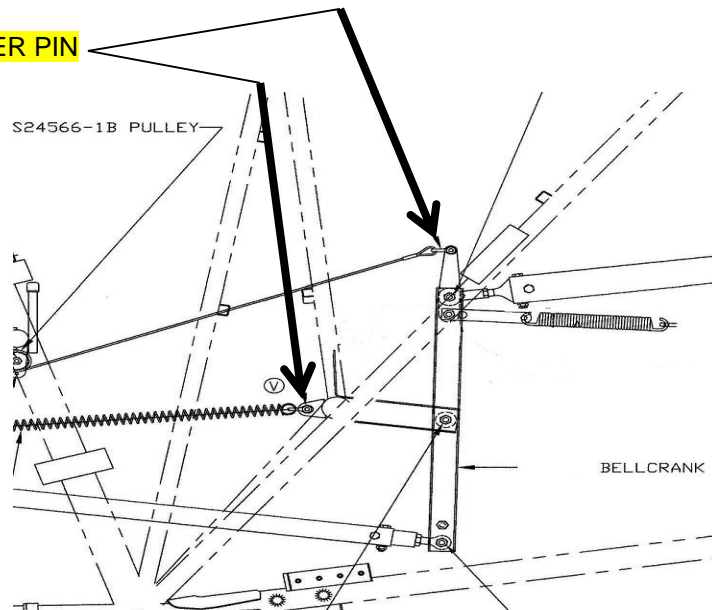
**FIGURE 58-3**

**VIEW LOOKING INBOARD FROM L/H SIDE CENTER OF FUSELAGE  
TYPICAL ALL SINGLE COCKPIT MODELS EXCEPT H80**

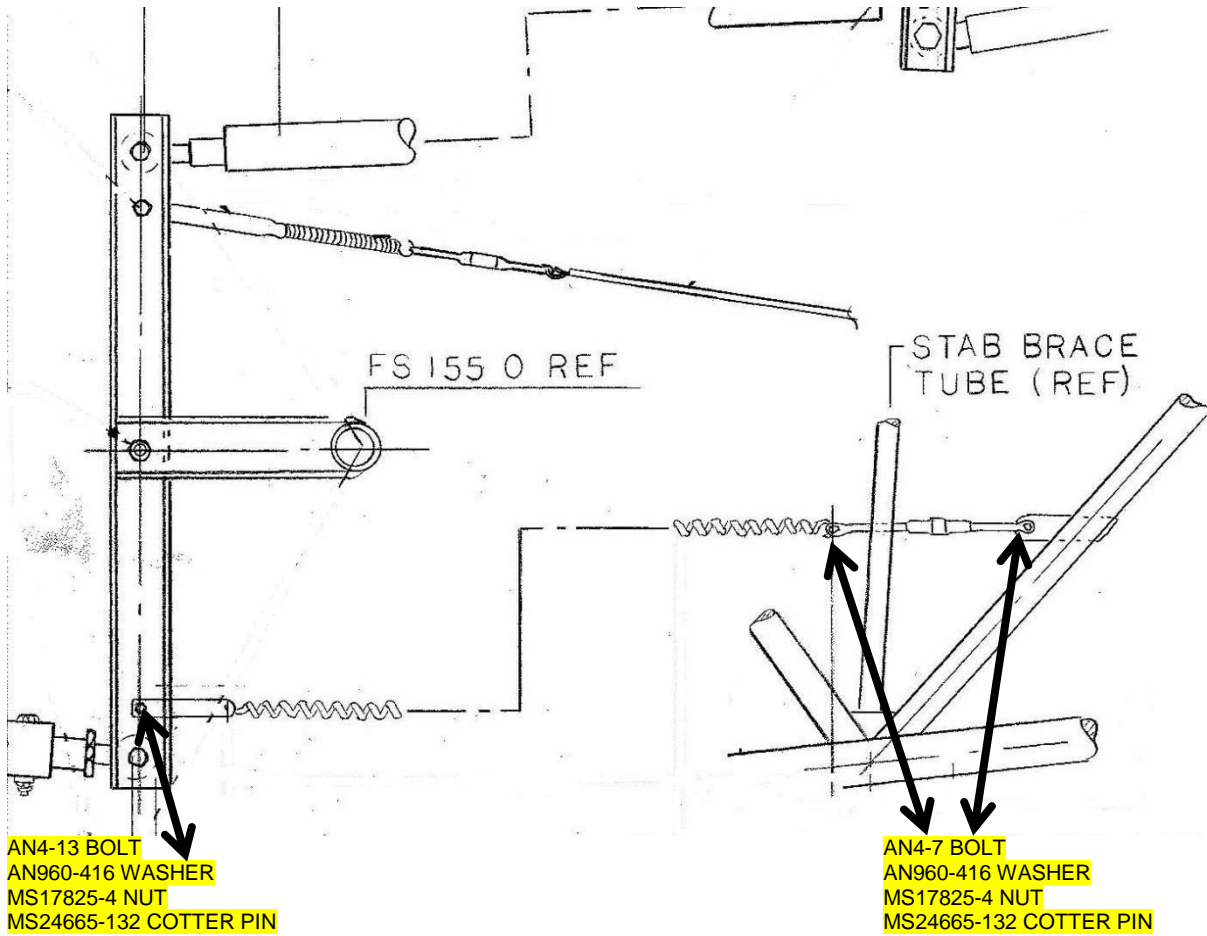
**FIGURE 58-4**

**VIEW LOOKING INBOARD FROM L/H SIDE AFT FUSELAGE  
TYPICAL ALL DUAL COCKPIT SINGLE CONTROL AND DUAL  
COCKPIT DUAL CONTROL ALL MODELS EXCEPT H80 AND T660**

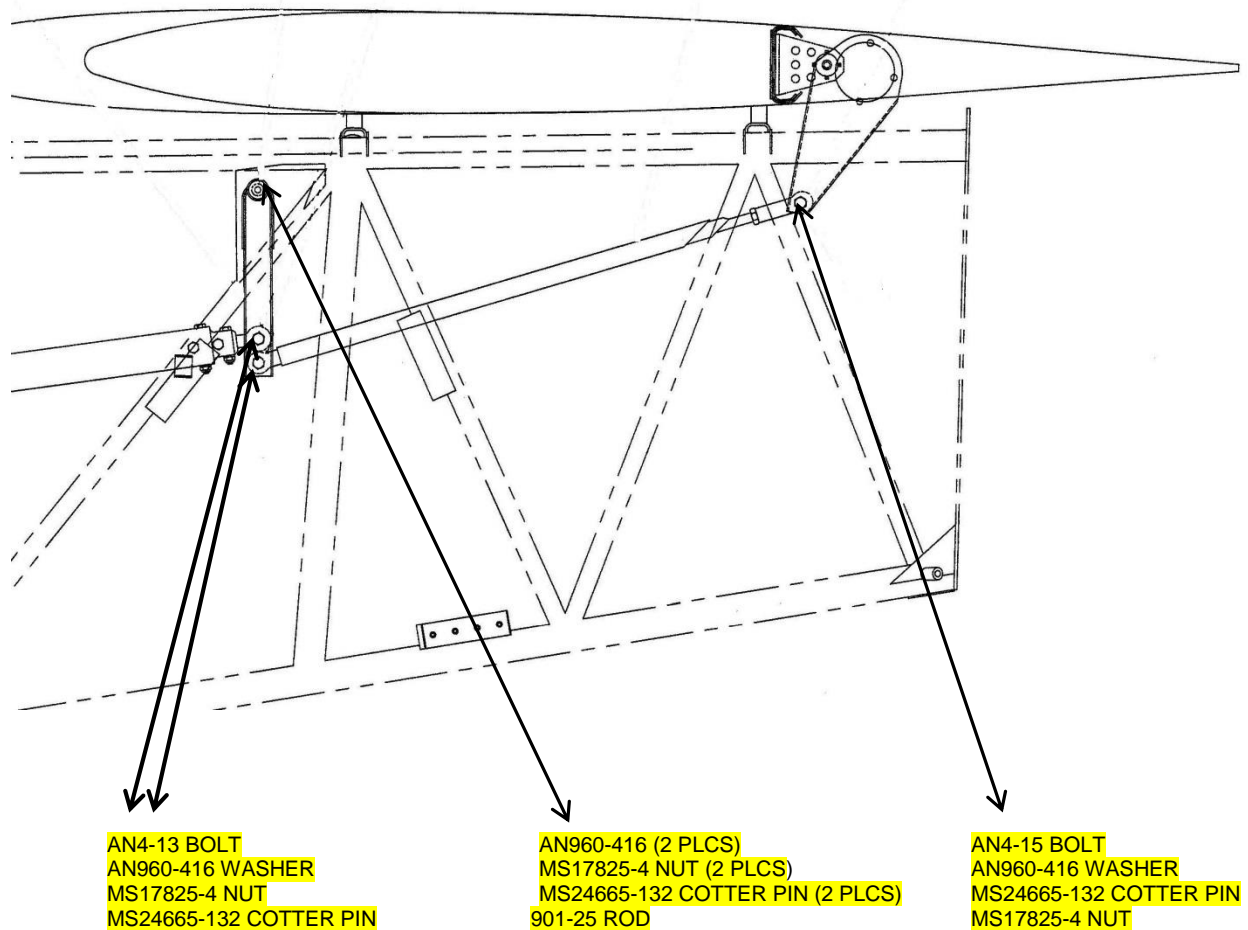
**FIGURE 58-5**

**VIEW LOOKING INBOARD FROM L/H SIDE AFT OF FUSELAGE  
TYPICAL ALL MODELS**

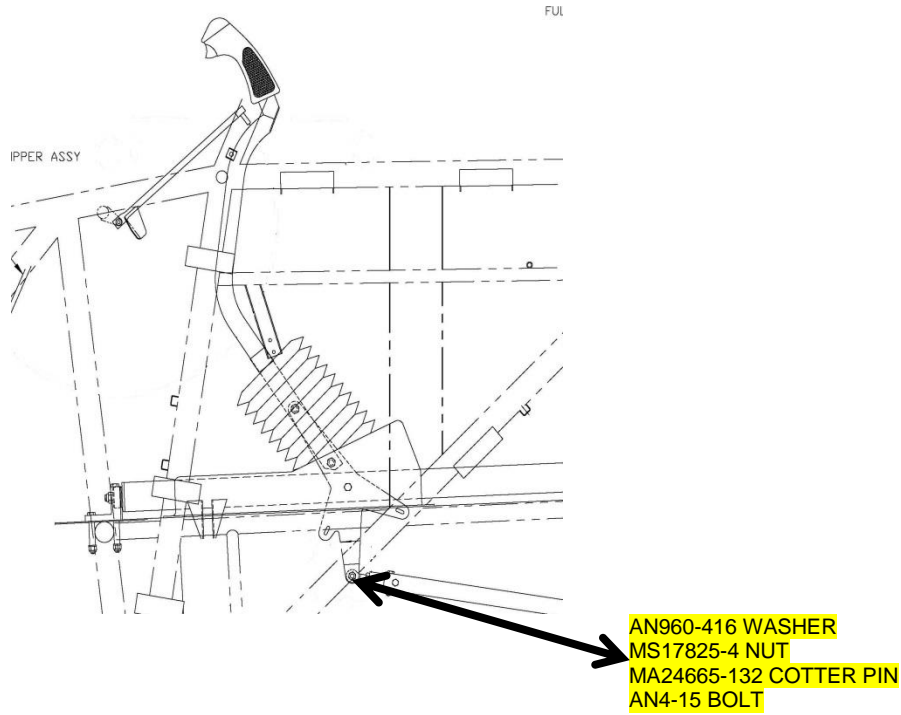
**FIGURE 58-6**

***VIEW LOOKING INBOARD FROM L/H SIDE FWD OF FUSELAGE  
TYPICAL ALL MODELS***

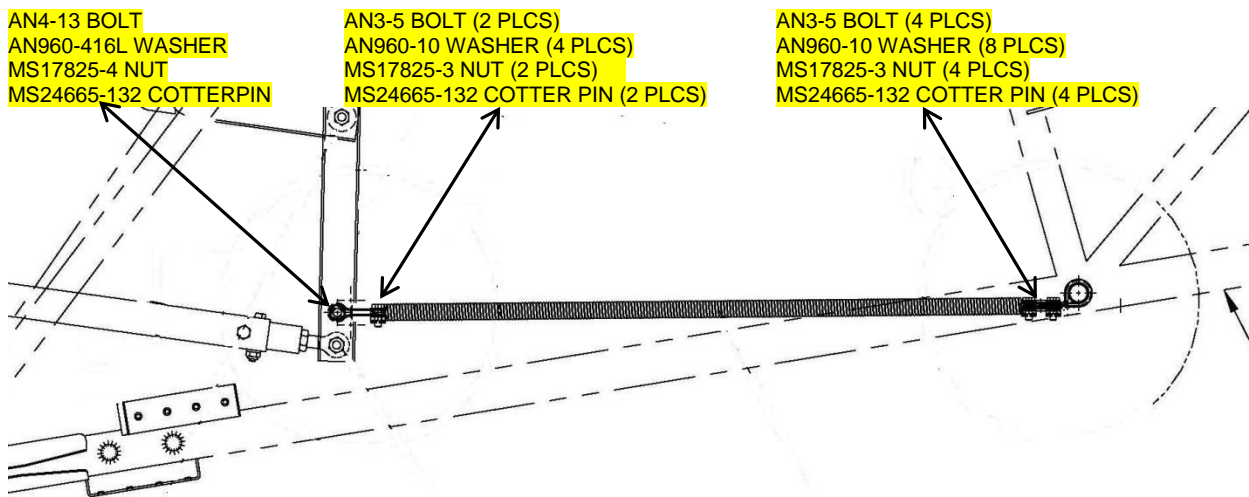
**FIGURE 58-7**

**VIEW LOOKING INBOARD FROM L/H SIDE CENTER OF FUSELAGE  
MODEL H80 SINGLE COCKPIT ONLY**

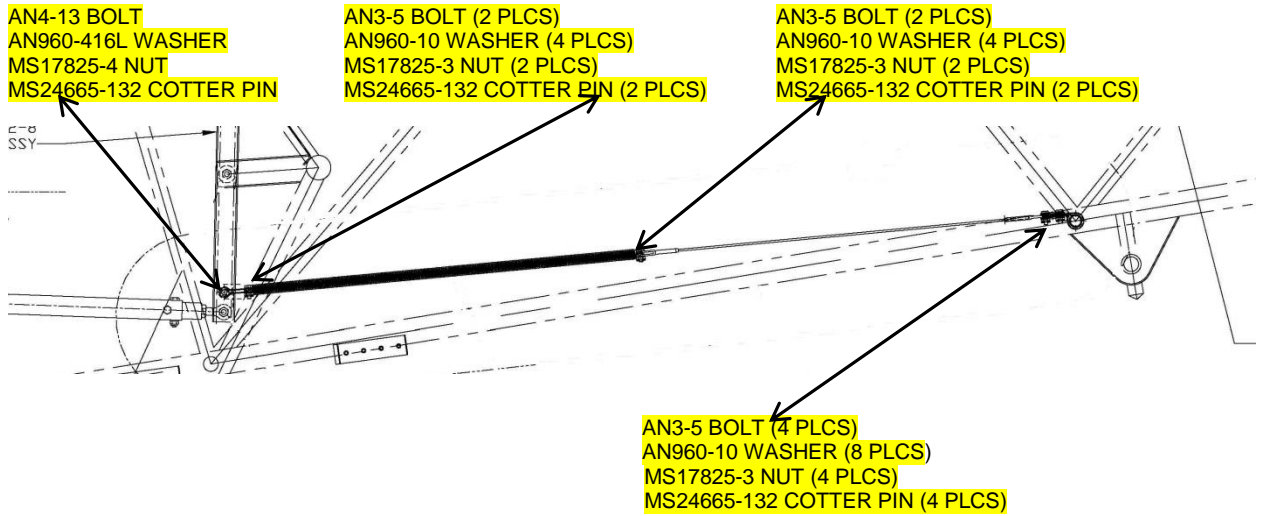
**FIGURE 58-8**

**VIEW LOOKING INBOARD FROM L/H SIDE CENTER OF FUSELAGE  
MODEL H80 DUAL COCKPIT SINGLE CONTROL AND DUAL  
COCKPIT DUAL CONTROL ONLY**

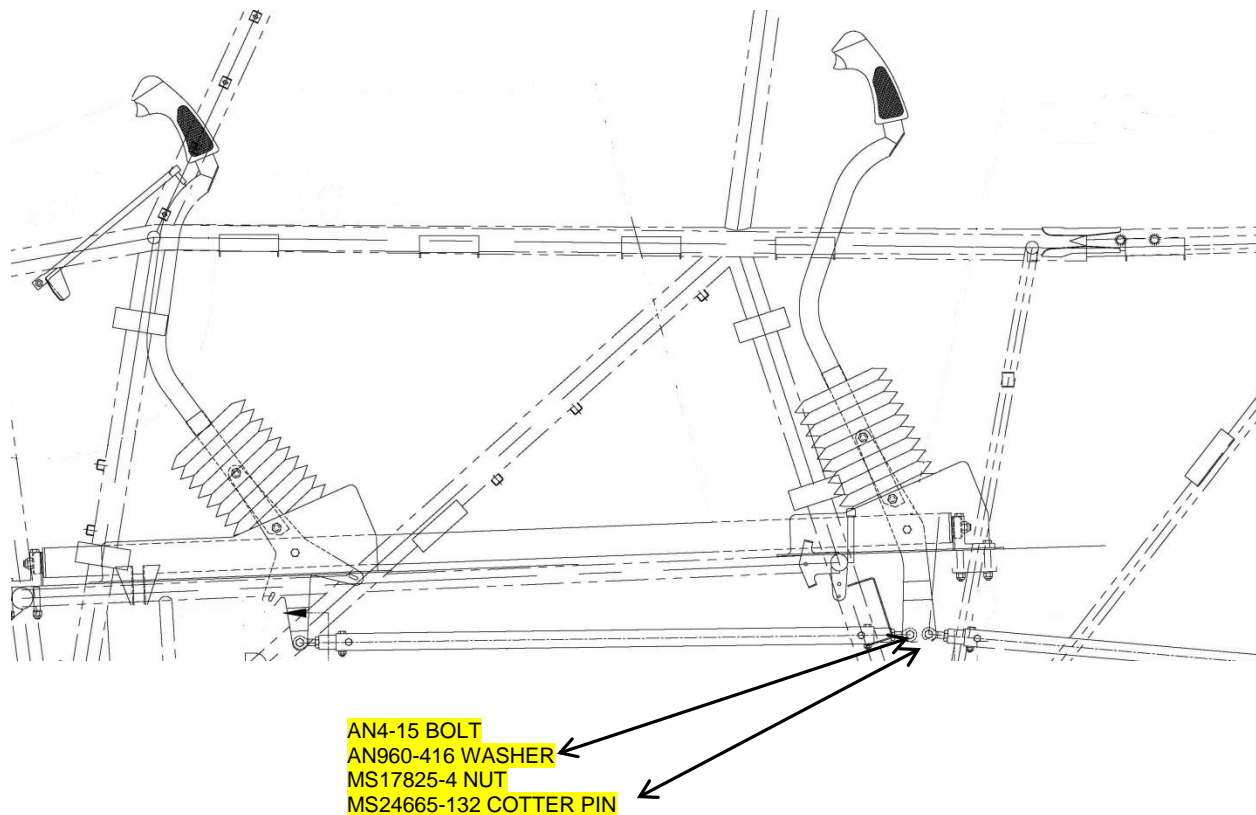
**FIGURE 58-9**

**VIEW LOOKING INBOARD FROM L/H SIDE OF  
CENTER OF FUSELAGE  
TYPICAL ALL DUAL COCKPIT MODELS**

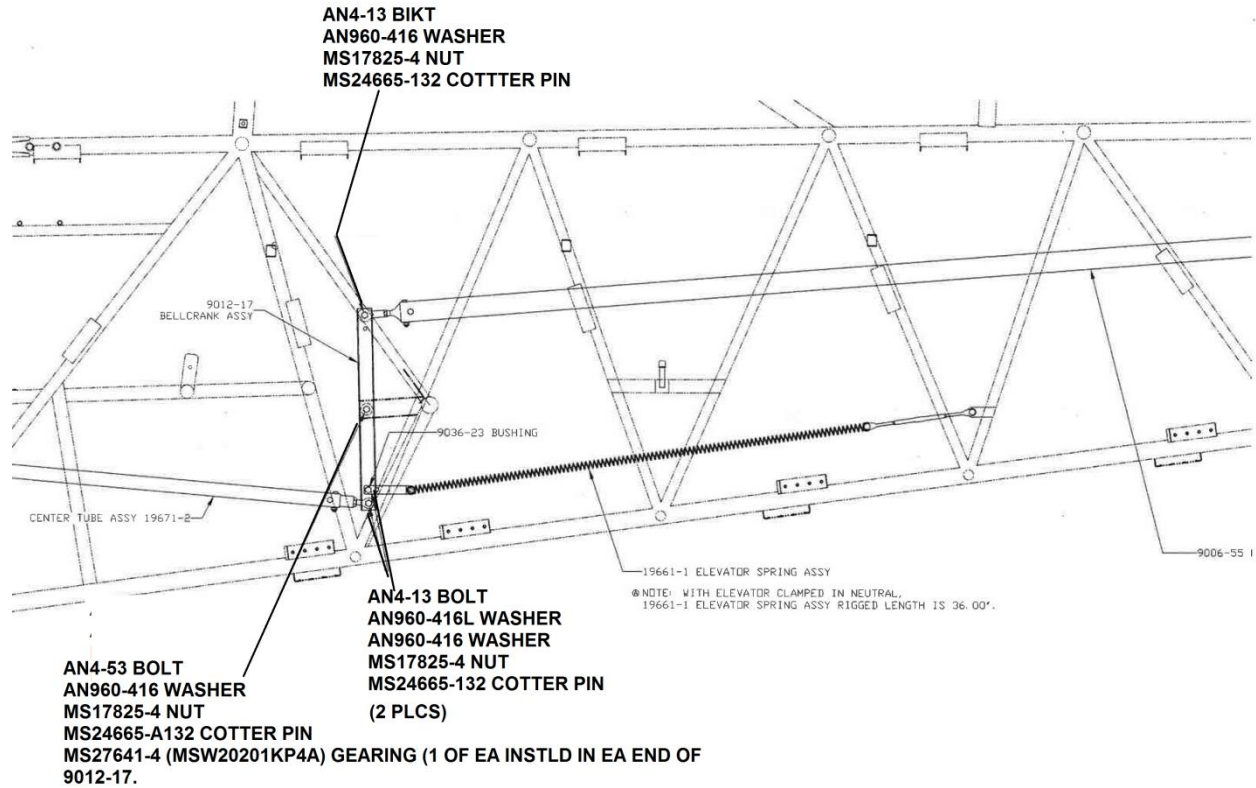
**FIGURE 58-10**

**VIEW LOOKING INBOARD FROM L/H SIDE OF  
AFT FUSELAGE  
TYPICAL T660 DUAL COCKPIT SINGLE CONTROL AND DUAL  
COCKPIT DUAL CONTROL MODELS**

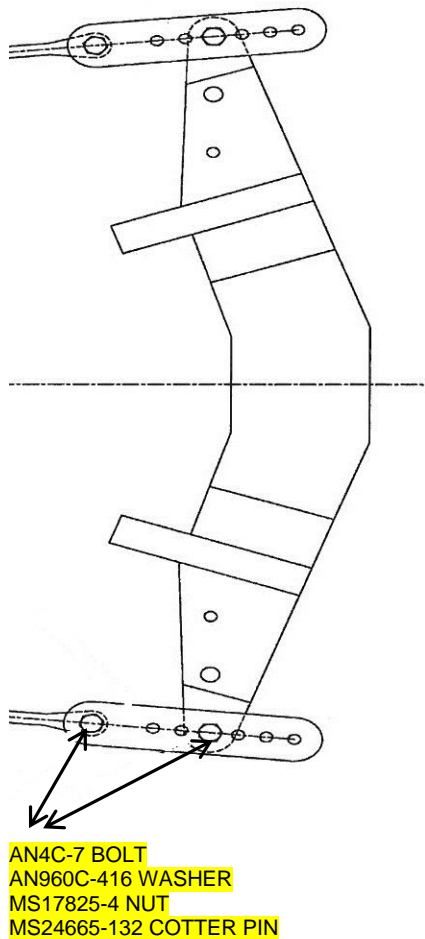
**FIGURE 58-11**

***VIEW LOOKING DOWN AT L/H SIDE OF RUDDER HORN  
RIGHT SIDE OPPOSITE  
TYPICAL ALL MODELS***

Inspect the applicable hardware using the diagrams below and replace existing hardware if it does not conform to the highlighted information.

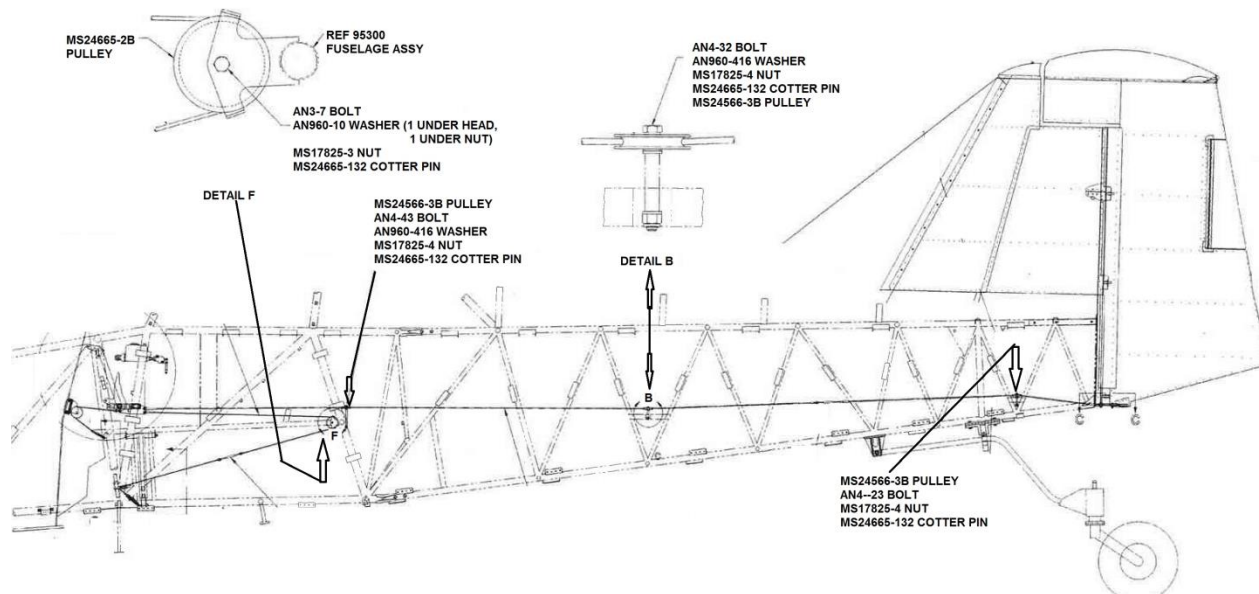
**FIGURE 58-14**  
**VIEW LOOKING INBOARD FROM L/H SIDE**  
**PULLEY DETAILS**  
**T660 SINGLE COCKPIT ONLY**

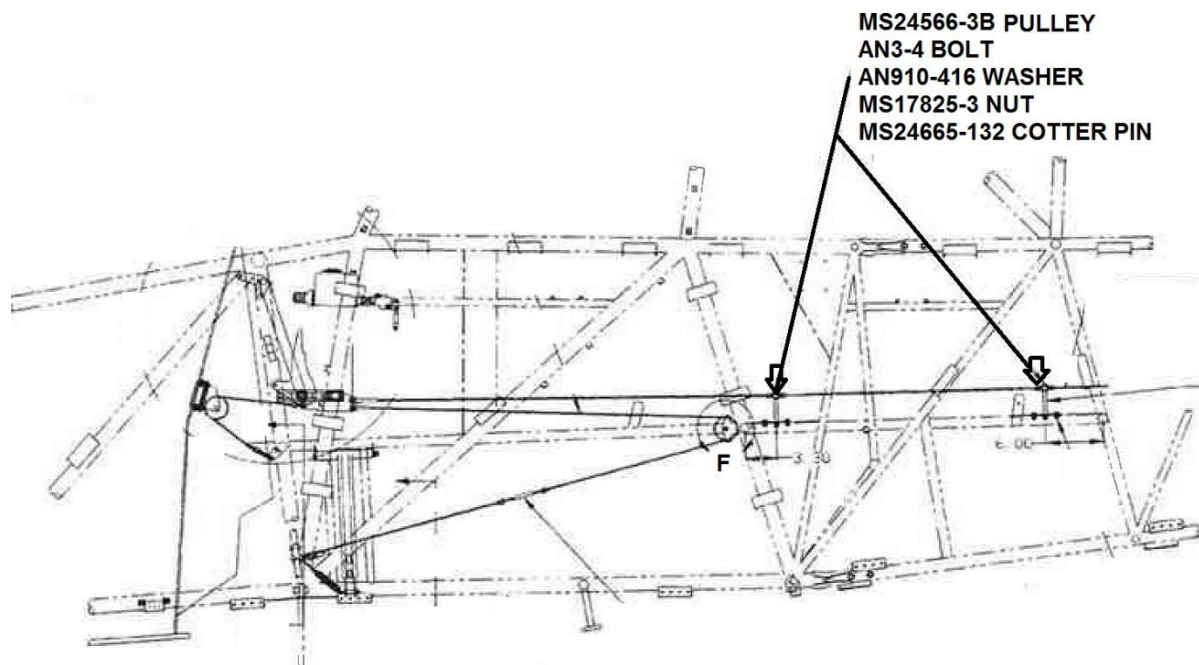
**FIGURE 58-15**  
**VIEW LOOKING INBOARD FROM L/H SIDE**  
**PULLEY DETAILS**  
**T660 DUAL COCKPIT SINGLE CONTROL ONLY**  
**SAME AS FIGURE 58-13 EXCEPT AS SHOWN**

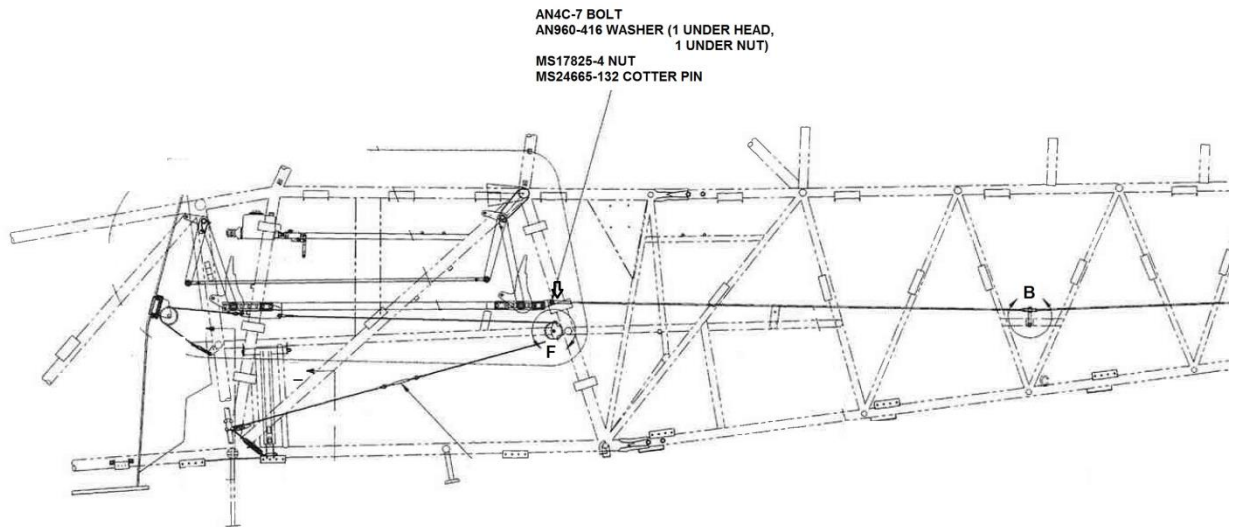
**FIGURE 58-16**

***VIEW LOOKING INBOARD FROM L/H SIDE PULLEY DETAILS  
T660 DUAL COCKPIT DUAL CONTROL ONLY  
SAME AS FIGURE 58-13 EXCEPT AS SHOWN***

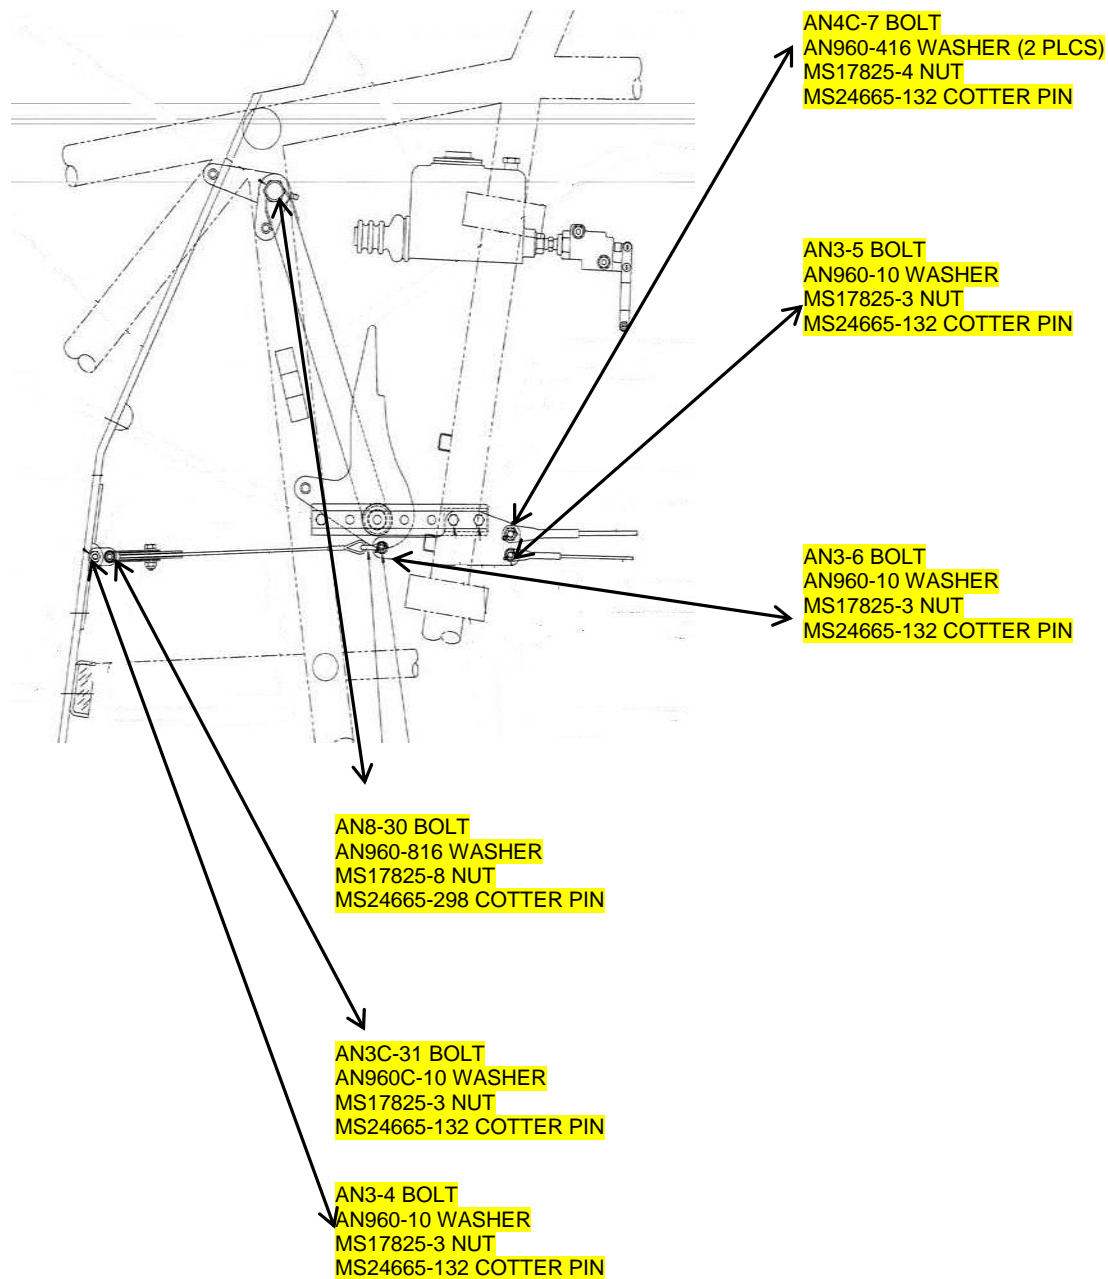
**FIGURE 58-17**

**VIEW LOOKING INBOARD FROM L/H SIDE FWD FUSELAGE  
RIGHT SIDE OPPOSITE  
TYPICAL ALL MODELS EXCEPT**

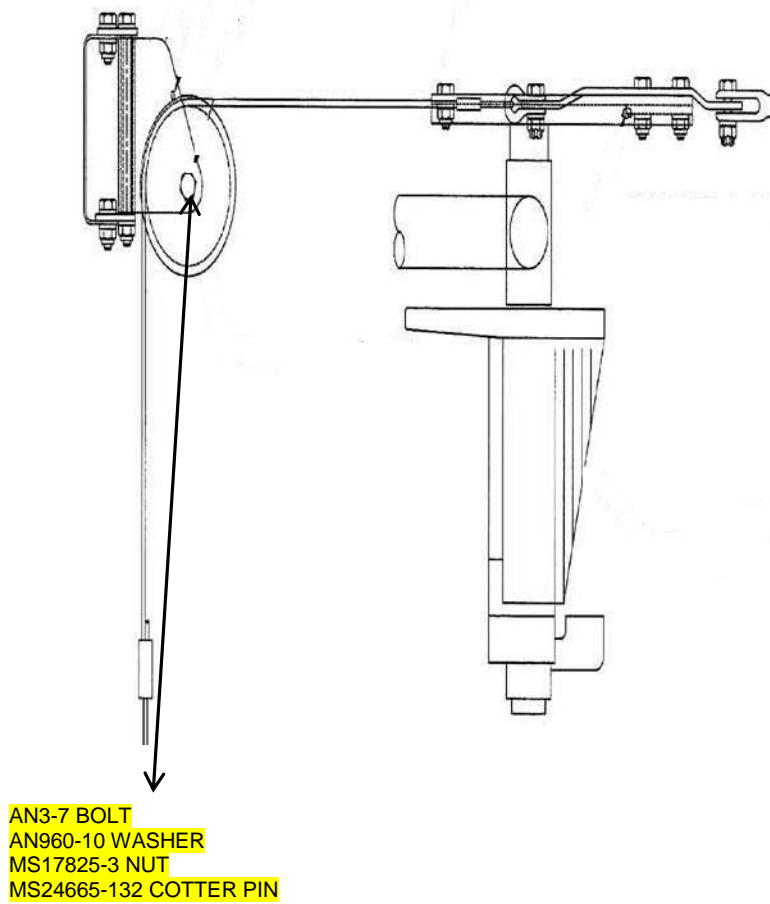
**FIGURE 58-18**

***VIEW LOOKING DOWN FROM R/H SIDE FWD FUSELAGE  
LEFT SIDE OPPOSITE  
TYPICAL ALL MODELS***

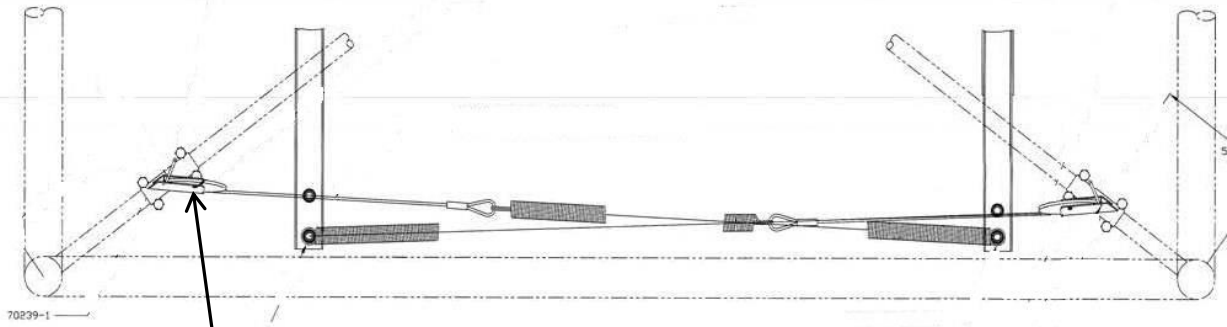
**FIGURE 58-19**

- PULLEY
- AN3-7 BOLT
- AN960-10 WASHER
- MS17825-3 NUT
- MS24665-132 COTTER PIN

***VIEW BENEATH COCKPIT FLOOR LOOKING FWD  
TYPICAL ALL MODELS EXCEPT H80***

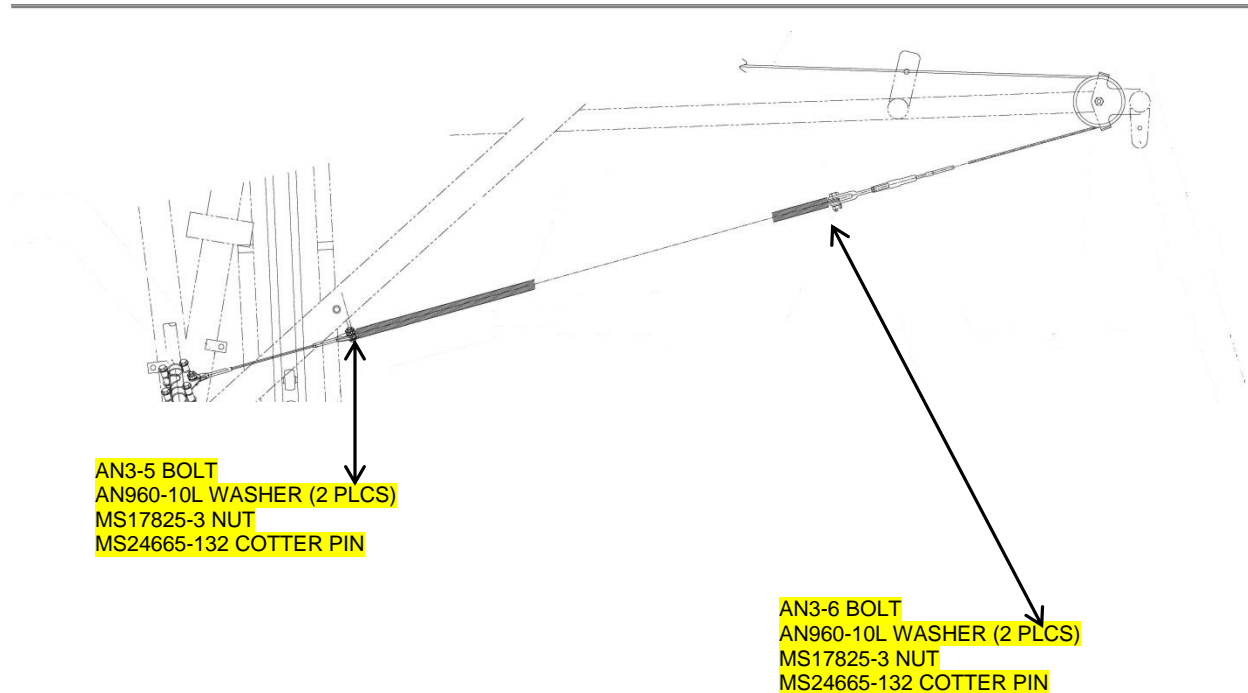
**FIGURE 58-20**

**VIEW LOOKING INBD FROM LEFT HAND SIDE OF COCKPIT  
LEFT SIDE SHOWN RIGHT SIDE OPPOSITE  
BENEATH THE COCKPIT  
TYPICAL MODEL H80 SINGLE, DUAL COCKPIT SINGLE CONTROL  
AND DUAL COCKPIT DUAL CONTROL**

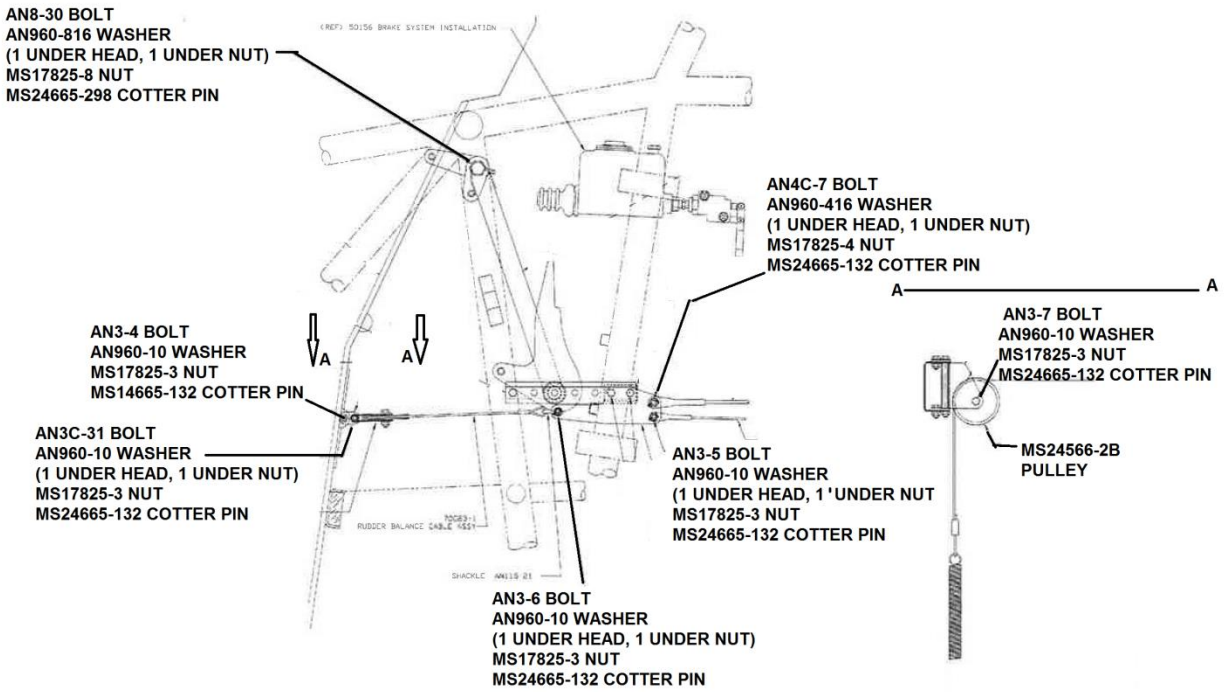
**FIGURE 58-21**

**VIEW LOOKING INBOARD  
LEFT SIDE SHOWN RIGHT SIDE OPPOSITE  
TYPICAL ALL SINGLE COCKPIT AND DUAL COCKPIT SINGLE  
CONTROL MODELS**

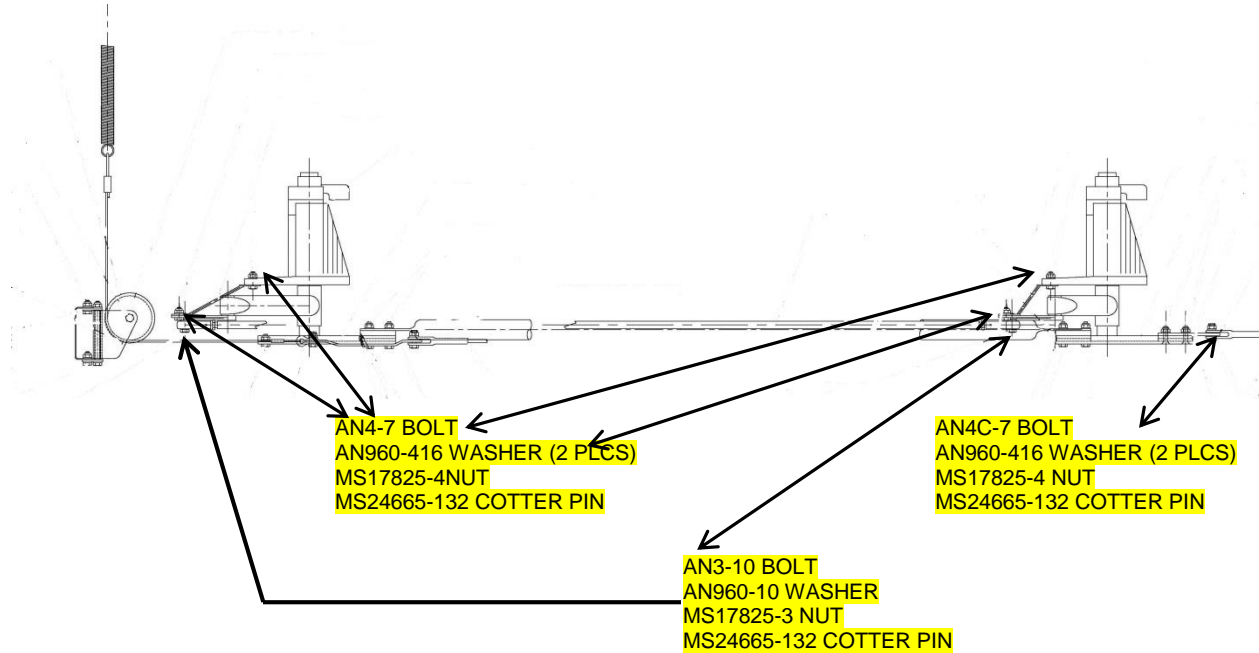
**FIGURE 58-22**

***VIEW INSIDE COCKPIT LOOKING DOWN  
LEFT SIDE SHOWN RIGHT SIDE OPPOSITE  
TYPICAL ALL DUAL COCKPIT DUAL CONTROL MODELS***

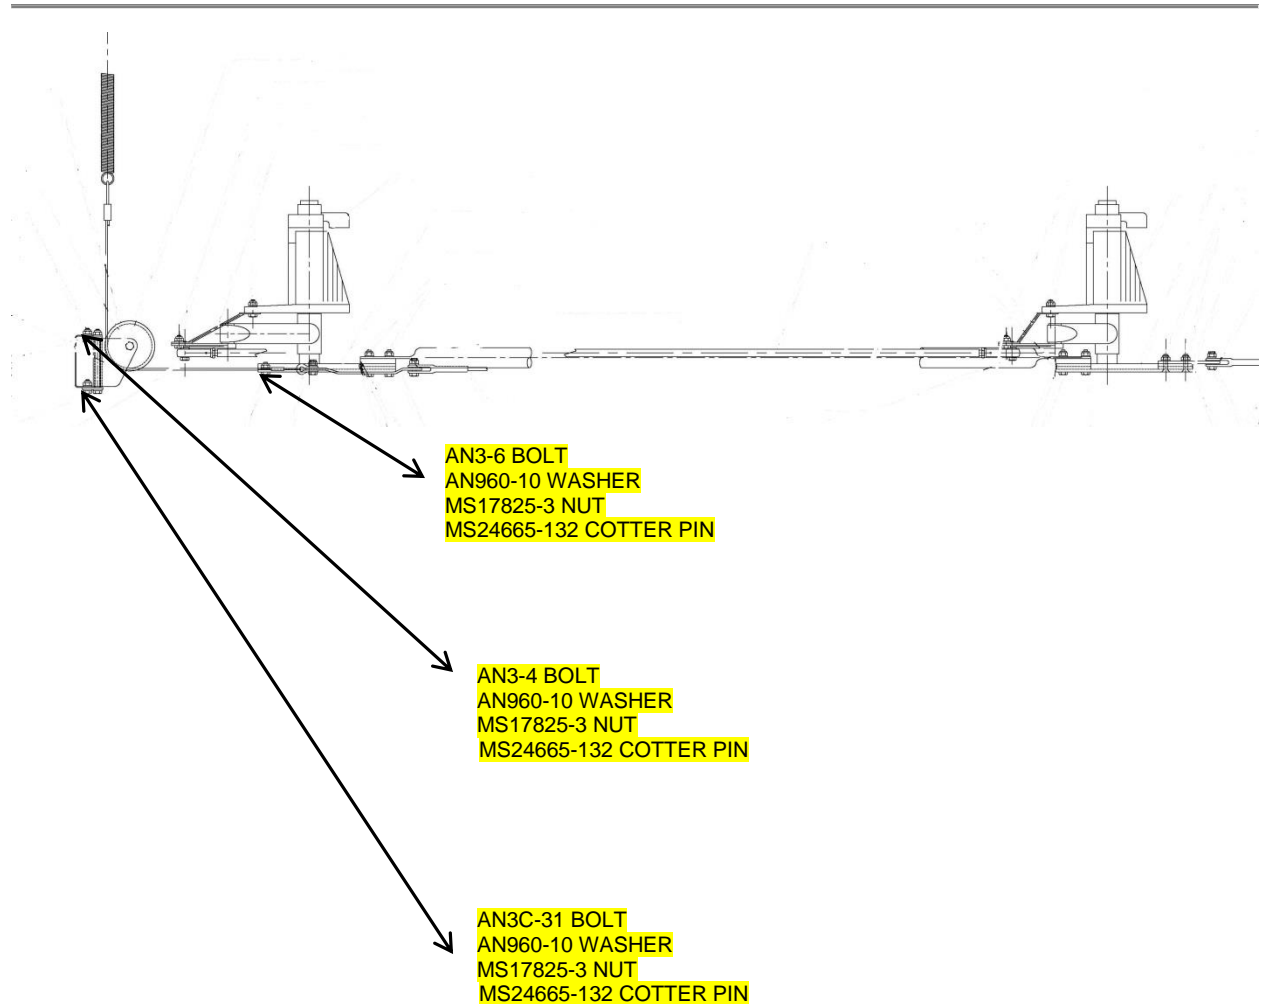
**FIGURE 58-23**

***VIEW INSIDE COCKPIT LOOKING DOWN  
LEFT SIDE SHOWN RIGHT SIDE OPPOSITE  
TYPICAL ALL DUAL COCKPIT/DUAL CONTROL MODELS***

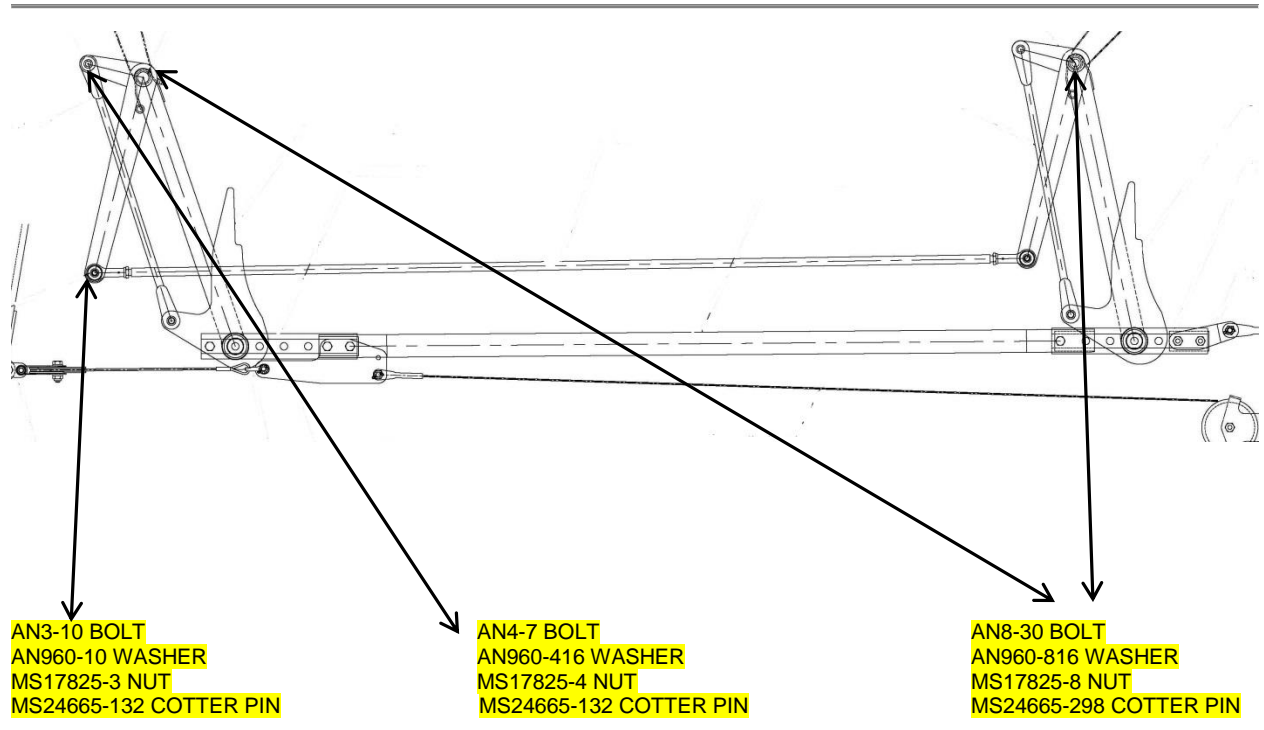
**FIGURE 58-24**

**VIEW LOOKING INBOARD FROM L/H SIDE FWD FUSELAGE  
RIGHT SIDE OPPOSITE  
TYPICAL ALL DUAL COCKPIT/DUAL CONTROL MODELS**

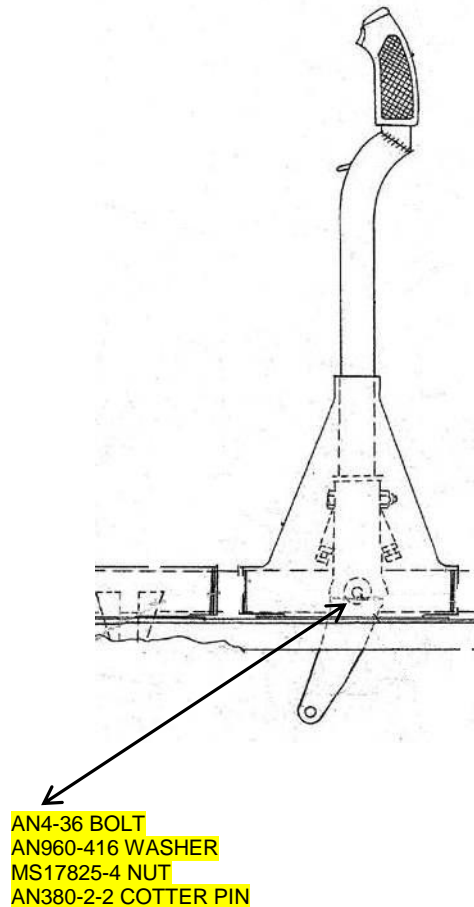
**FIGURE 58-25**

***VIEW LOOKING INBOARD FROM L/H SIDE FWD FUSELAGE  
TYPICAL ALL MODELS EXCEPT***

Inspect the applicable hardware using the diagrams below and replace existing hardware if it does not conform to the highlighted information.

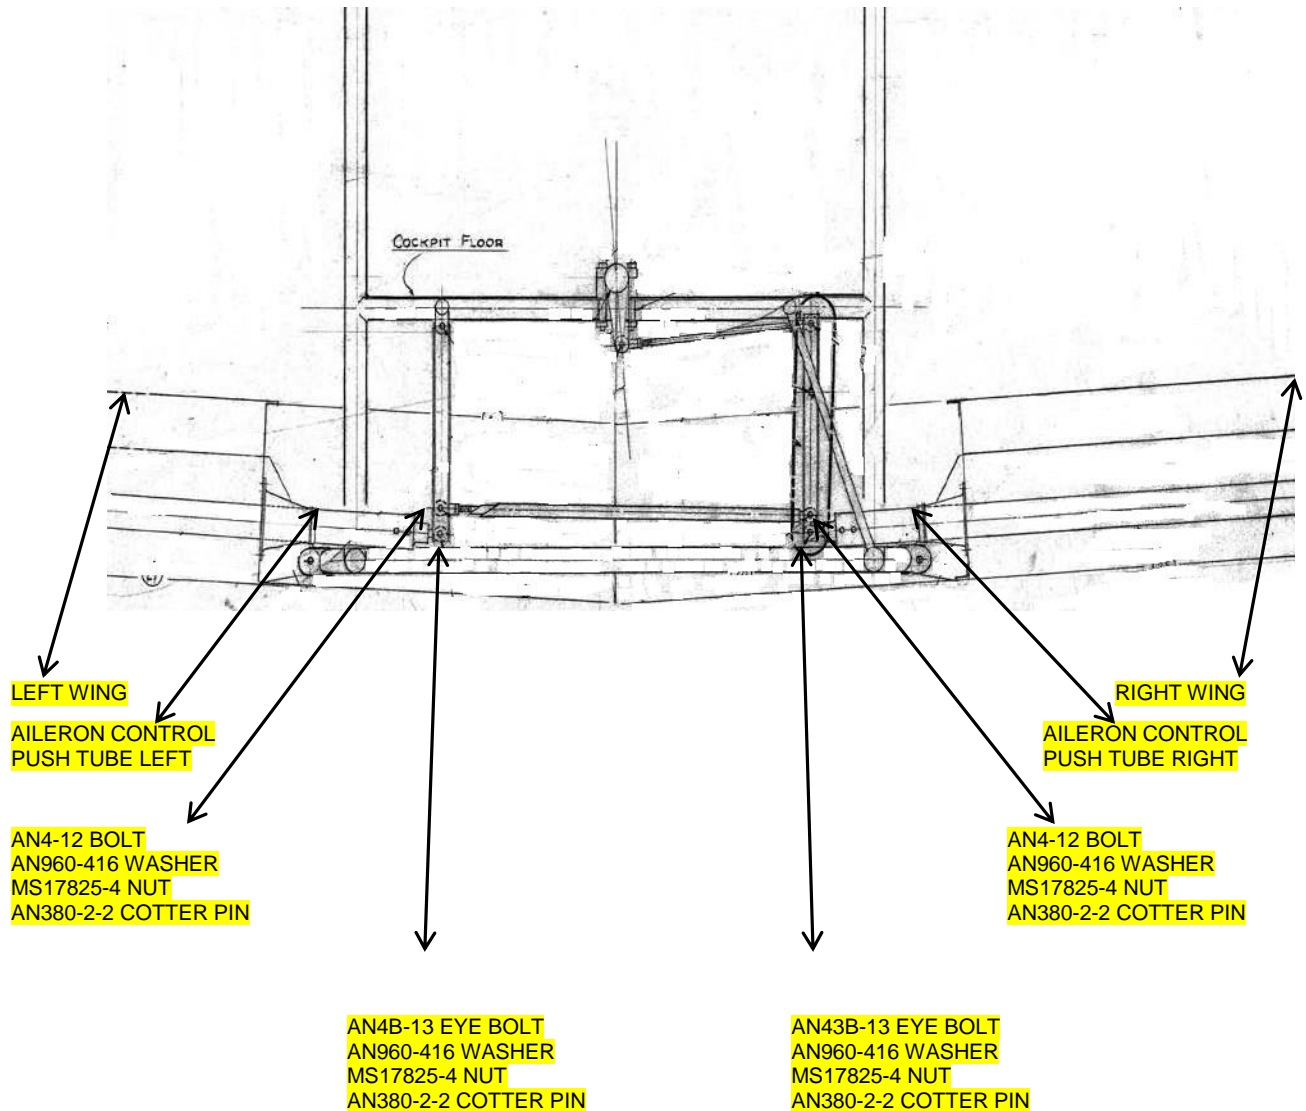
**FIGURE 58-26**

**VIEW LOOKING FWD FROM BENEATH THE COCKPIT  
TYPICAL ALL MODELS EXCEPT H80 AND T660**
