# SERVICE BULLETIN

## No. SB-AG-58

Revision A 10/15/2015

ELEVATOR, RUDDER, AND AILERON CONTROL SYSTEMS  
INSPECTION AND HARDWARE REPLACEMENT TO  
INCORPORATE CASTELLATED NUTS IN JOINTS SUBJECT  
TO ROTATION

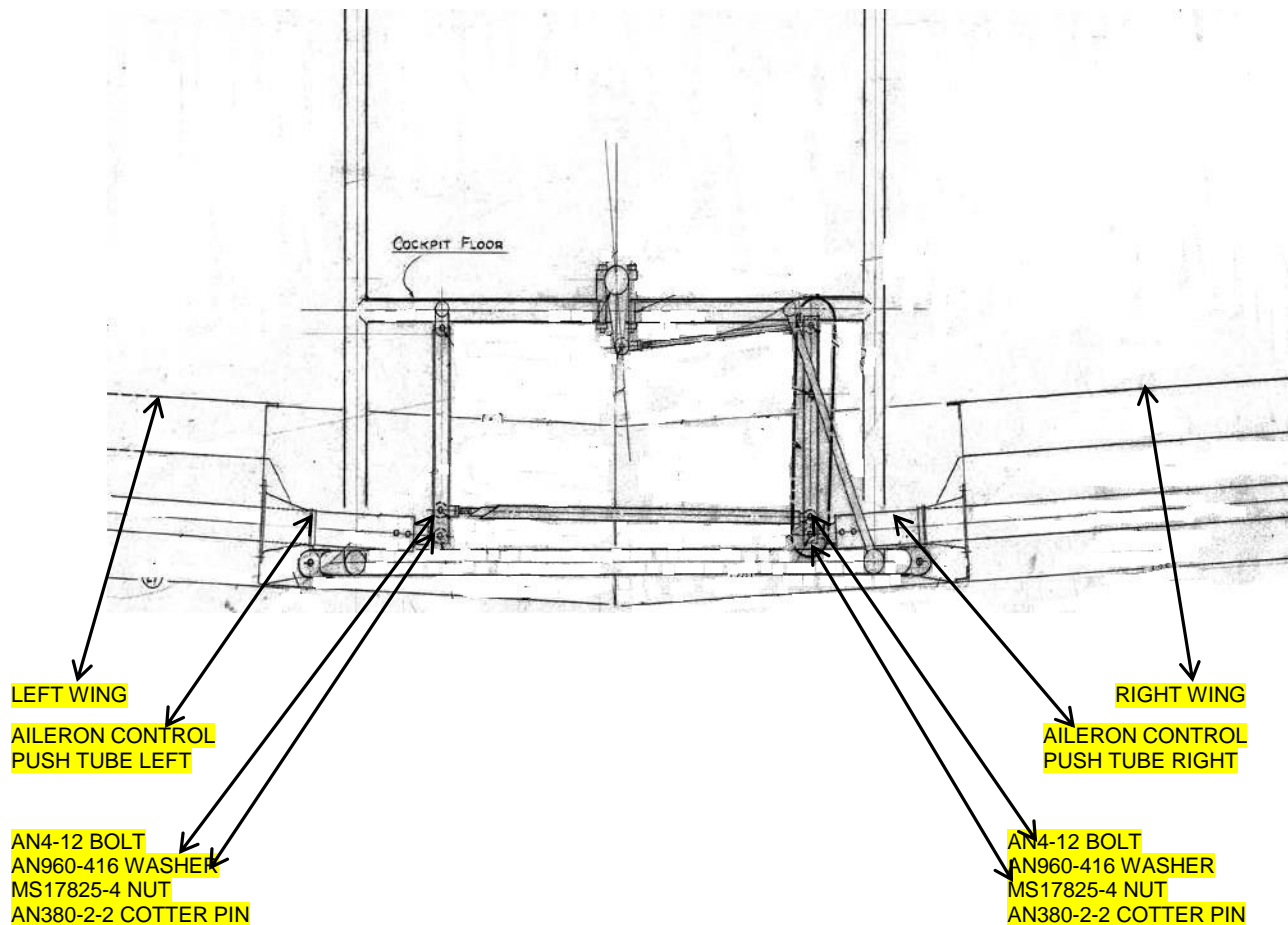
**FIGURE 58-27**

***VIEW LOOKING FWD FROM BENEATH THE COCKPIT  
TYPICAL H80***

Inspect the applicable hardware using the diagrams below and replace existing hardware if it does not conform to the highlighted information.

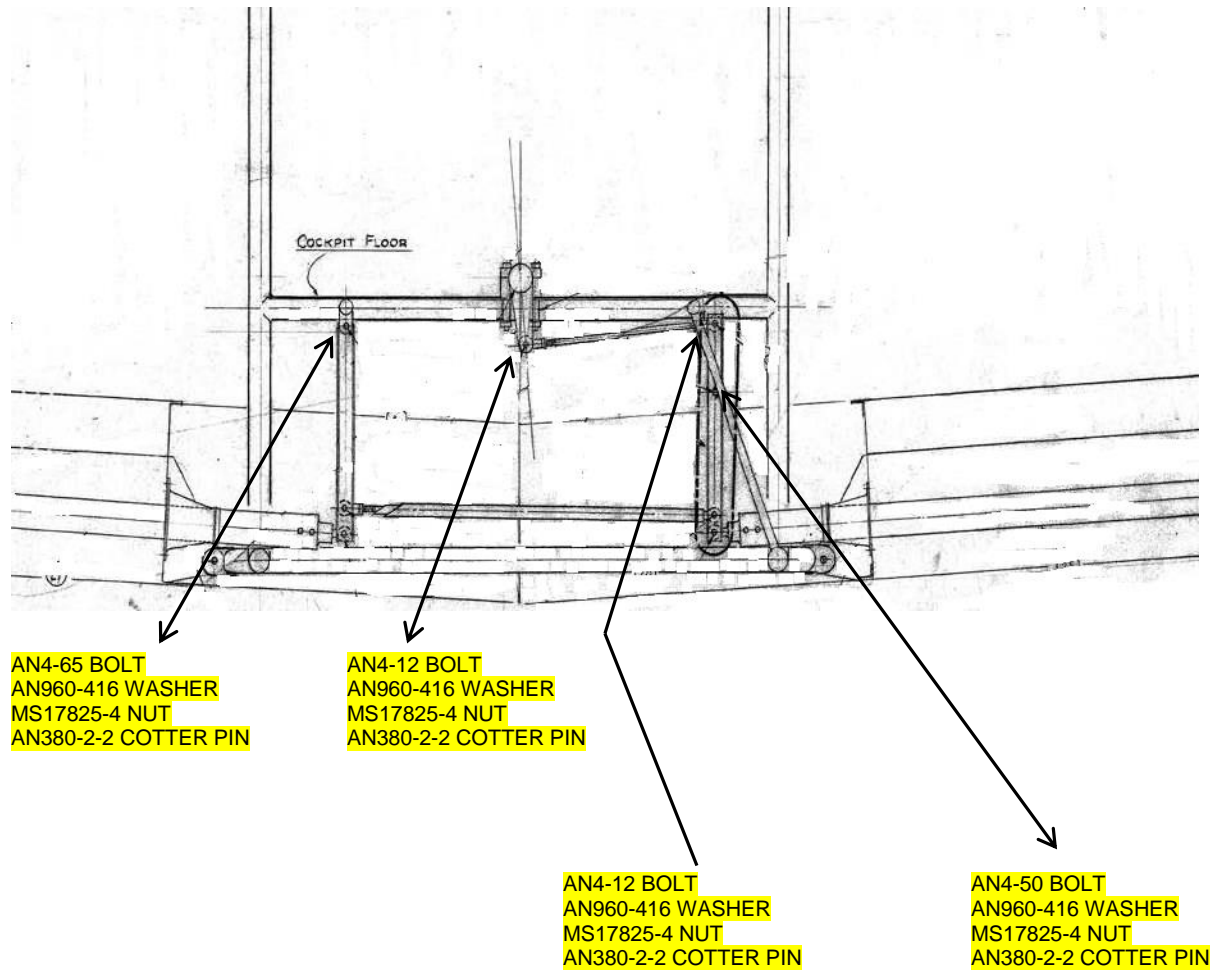
**FIGURE 58-28**

***VIEW LOOKING FWD FROM BENEATH THE COCKPIT  
TYPICAL ALL MODELS***

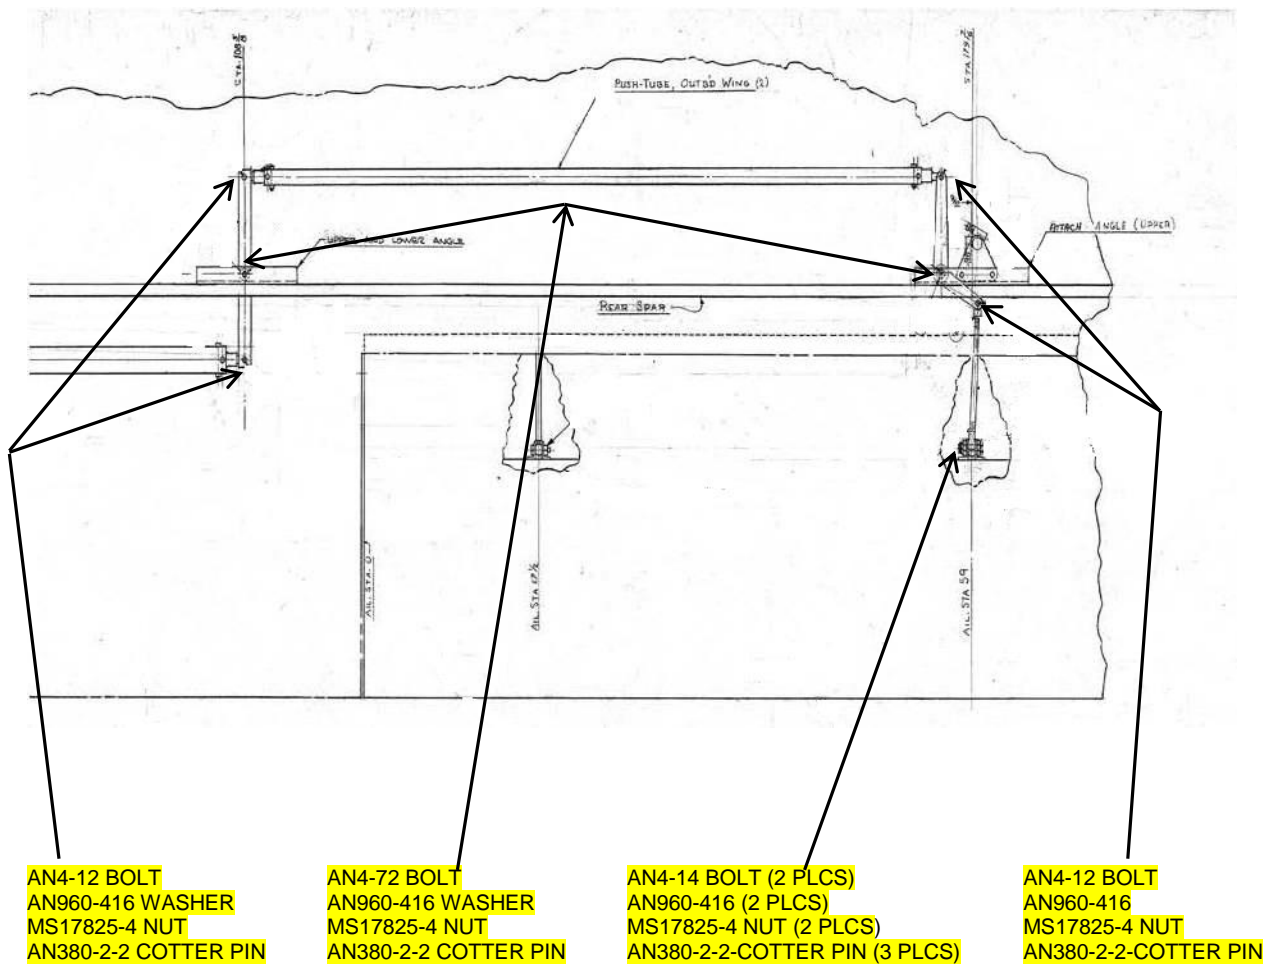
**FIGURE 58-29**

**TOP VIEW OF RIGHT AILERON AND WING  
TYPICAL ALL MODELS EXCEPT T660**

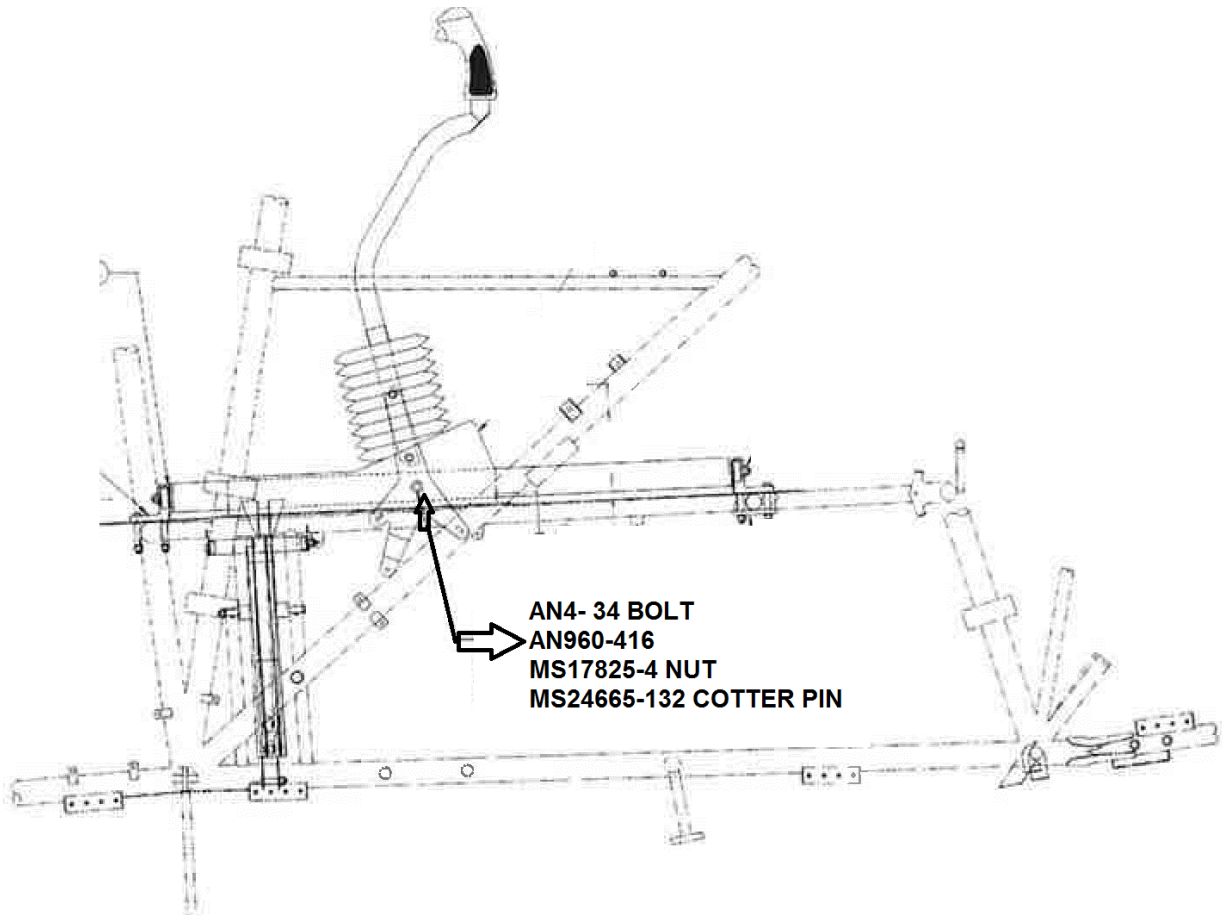
**FIGURE 58-30**

***VIEW LOOKING INBOARD FROM L/H SIDE FWD FUSELAGE  
T660  
2 PLACES FOR DUAL COCKPIT DUAL CONTROL***

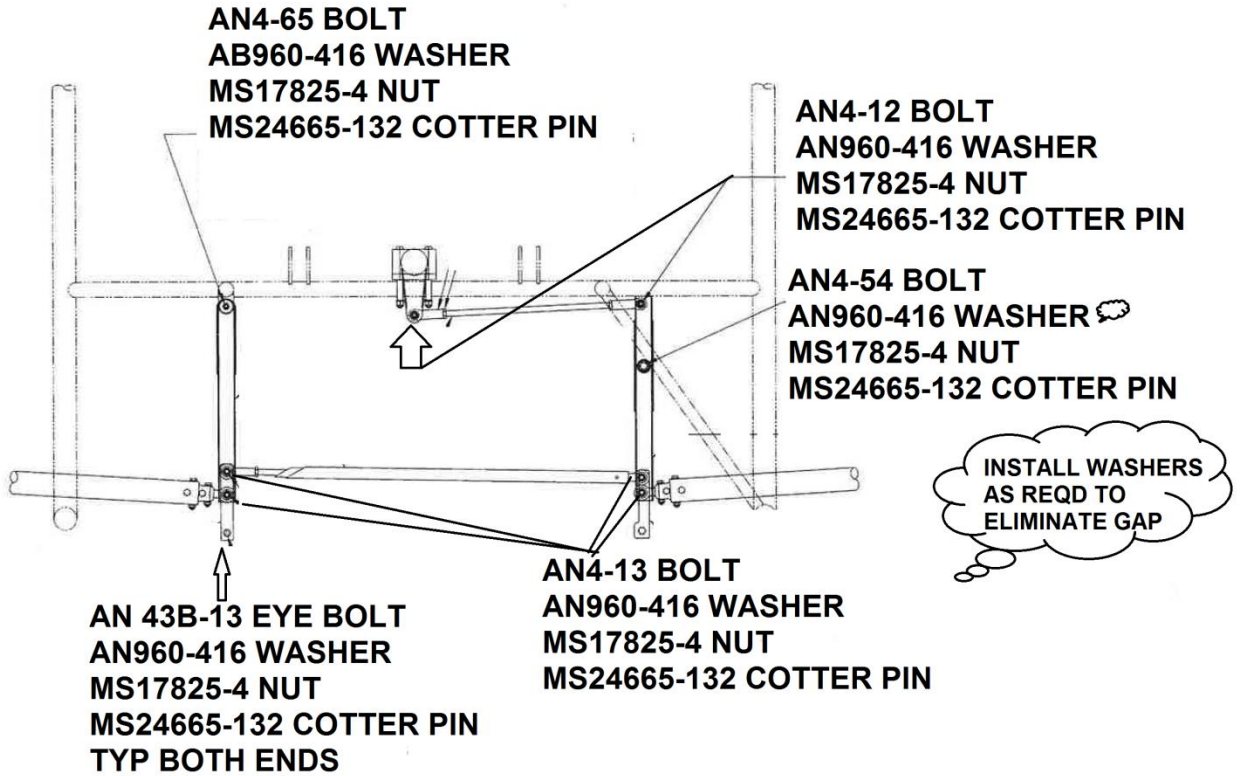
**FIGURE 58-31**

**VIEW LOOKING FWD FROM BENEATH THE COCKPIT  
T660**

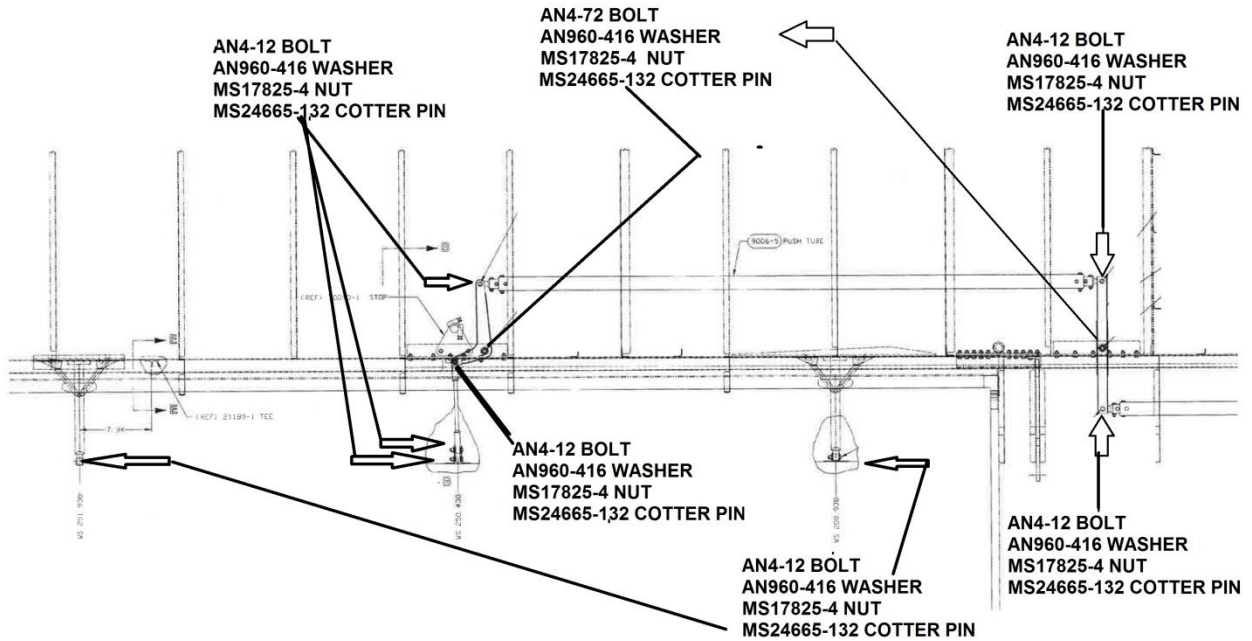
**FIGURE 58-32**

**TOP VIEW OF LEFT AILERON AND WING  
T660**
