Rockwell service letter No. SL-AG-72

Service Letter No. SL-AG-72
June 19, 1975

WIND GUST DAMAGE TO AILERONS

MODELS AFFECTED: MODEL S-2R, SERIAL NO'S 1416R AND SUBS

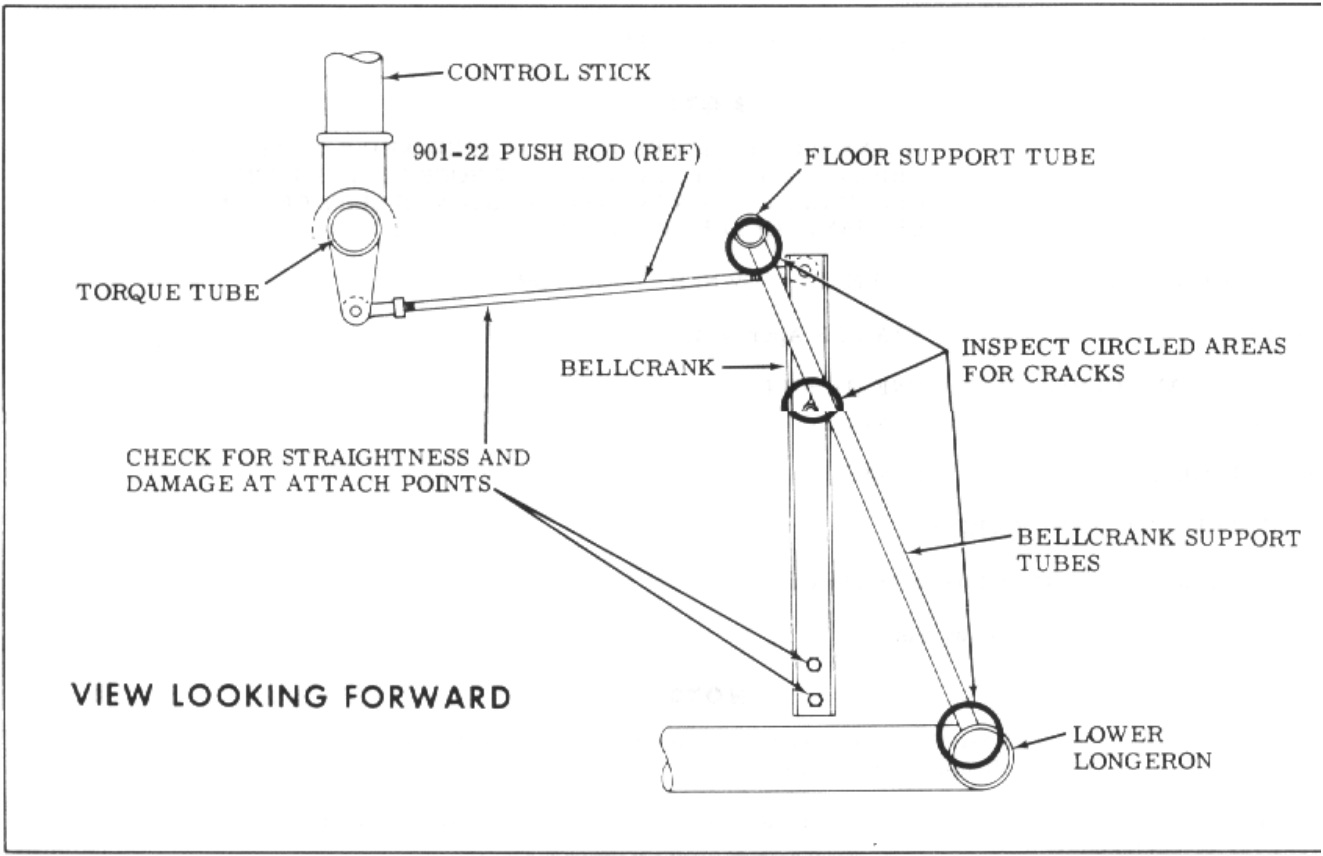
REASON FOR PUBLICATION: There have been several reports of bent push rods in the aileron control system due to strong wind with the airplane tied down in a position with the tail into the wind. This Service Letter is being issued to provide for inspection of the aileron control system for possible wind damage.

3. If there is no resistance to movement or the ailerons are not streamlined, the aileron control system may be damaged.
4. If evidence of damage is present, check aileron control system in areas shown in Figure 1. and repair as necessary.
5. Return airplane to service.

Wind gust locks should be installed between the ailerons and the wing tips to prevent any movement if the airplane is to be subjected to strong or gusty winds when moored.

An economical gust lock may be made by using two 6" x 6" x 3/4" plywood blocks with a 1/4" diameter hole drilled through the center of each block and covered with discarded inner tube rubber or other protective material. Use a 1/4" bolt and wing nut to secure the two plates together. Place one plate on the upper surface and the other on the lower surface with the bolt in the slot between wing tip and aileron. A red flag should be secured to the gust lock.
