Service Bulletin No. SB-AG-23

July 11, 1989

### WING SPAR INSPECTION

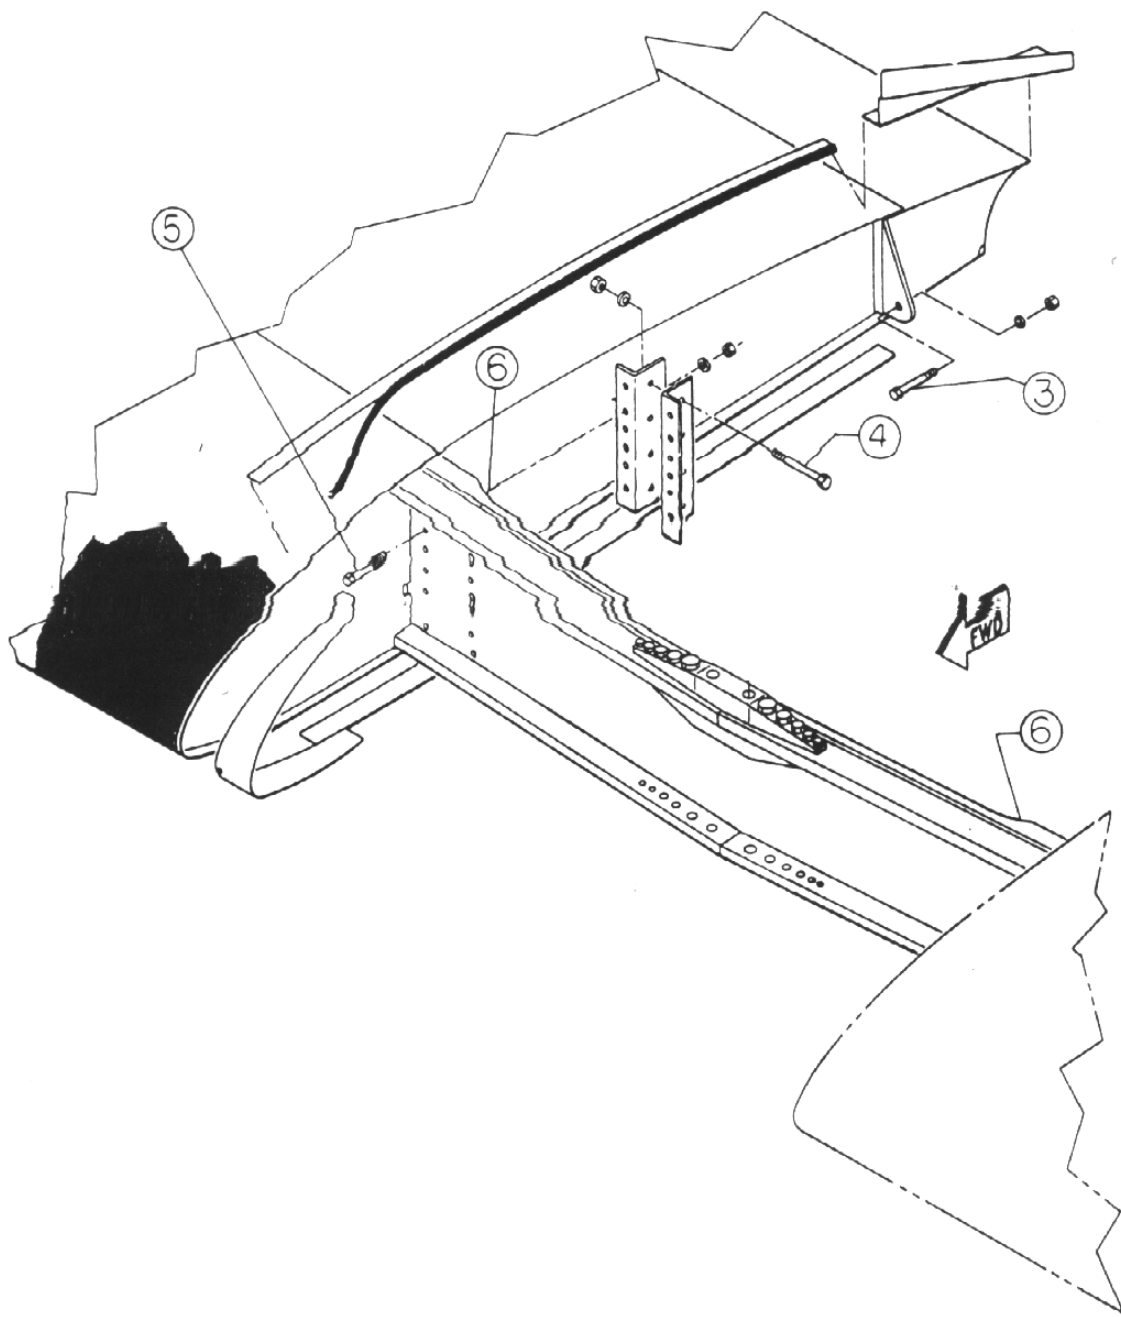
FIGURE A

REASON FOR PUBLICATION: This Service Bulletin is being issued to provide for periodic inspection of the wing main spar fatigue cracks and loose fasteners.

6. Inspect for cracks in the wing spar web flanges at the locations shown in Note (6) on Figure A. This area is the web flange just inboard of the inboard wing attach angles. Inspect the web flange at 4 places, upper and lower, left and right. If cracks are found that do not extend out of sight behind the steel spar cap, stop drill the crack (No. 40). The repair is then complete. If cracks are found that extend into the sandwich formed by the layers of spar material, the wing must be repaired using Ayres Kit No. S2R-FF-002. Contact your nearest dealer or the Ayres factory.
7. After the initial inspection and any necessary repairs are completed, fill out and return the enclosed compliance card indicating the results of the inspection. Reinspect the aircraft every 500 hours thereafter and record the inspection with a log book entry.

1. Remove left and right belly skins located just aft of the firewall. Remove the wing root fairing strips: forward, upper and lower.
2. Remove the fuselage side skins at the wing root area.
3. Inspect the rear wing attach bolts (1 per side, AN7-21A) for proper torque (450-500 inch pounds). See (3) on Figure A.
4. Inspect the fuselage to wing attach angle bolts (4 per side, AN5-27A) for proper torque (100-140 inch pounds). See (4) on Figure A.
5. Inspect the wing spar to wing attach angle bolts (12 per side, AN4-13A) for proper torque (50-70 inch pounds). See (5) on Figure A.

IF ANY BOLTS ARE LOOSE IN THEIR HOLES, REMOVE THE BOLT AND CHECK THE BOLT FOR WEAR AND THE HOLE FOR ELONGATION. IF ANY DAMAGE IS FOUND, CONTACT YOUR NEAREST DEALER OR THE AYRES FACTORY WITH DETAILS. TELEPHONE 229-883-1440 OR FAX 229-439-9790.
