THRUSH AIRCRAFT, INC.

SERVICE BULLETIN No. SB-AG-47

AUGUST 10, 2005

UPPER LONGERON INSPECTION

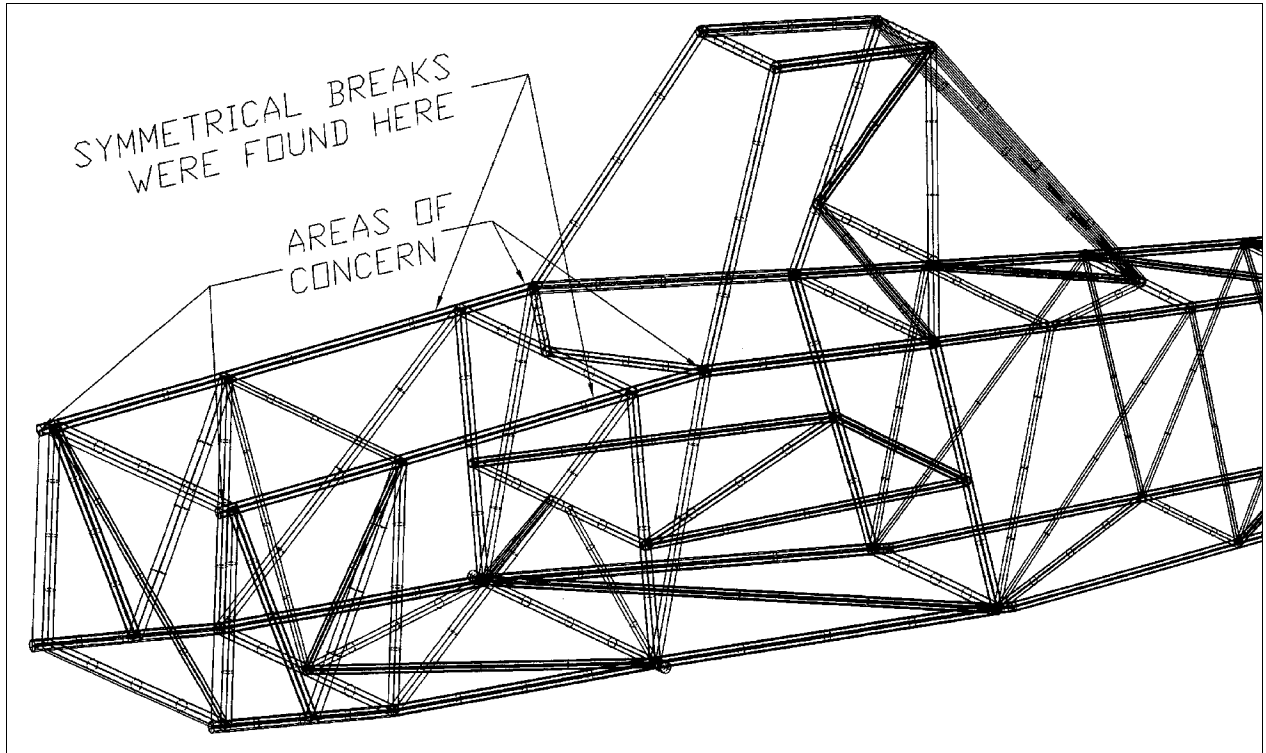
FRAME INSPECTION AREA

The longerons forward of the cockpit support the hopper, and previous problems have usually been associated with corrosion resulting from moisture trapped between the hopper and the longeron. The reported symmetrical failure of both longerons occurred where the aft hopper mount bracket is welded to the longeron. Simultaneous and symmetrical failures from corrosion are unheard of.

The required inspection is a careful visual inspection of the fuselage upper longerons for cracks, from immediately in front of the cockpit to the front of the frame. A flashlight with a strong, well focused beam should be used. The lower half of the longerons can be seen easily from below, although excess Cab-O-Sil filled resin used to hold the hopper may need to be removed in some areas. Any areas of corrosion must be stripped of paint and cleaned with a wire brush and/or abrasive cloth down to bright metal.

Inspection of the upper half of the longerons is more difficult because of the hopper. These areas must be inspected from inside the hopper, through the translucent hopper walls. The longerons are factory finished a light grey, so inspection through the hopper walls will focus on the uniformity of color. Any evidence of discoloration of the longeron surface is indicative of corrosion and possible cracking.

Cracks found on the lower half of the longeron, or discoloration, indicating corrosion, on the upper half of the longerons, requires removal of the hopper. Cracks will require welding repairs per AC 43.13, latest revision, and any corrosion must be fully removed and the bright metal longeron surface inspected for cracks. After corrosion or crack repairs, the tubes must be refinished with polyurethane primer to protect them from future corrosion.
