# Rockwell service letter No. SL-AG-73

Service Letter No. SL-AG-73  
July 7, 1975

### REPLACEMENT OF TAIL WHEEL SHOCK STRUT EXTENSION ASSEMBLY

**MODELS AFFECTED:** MODEL S-2R, SERIAL NO'S 2167R THRU 2173R AND 5011R THRU 5048R.

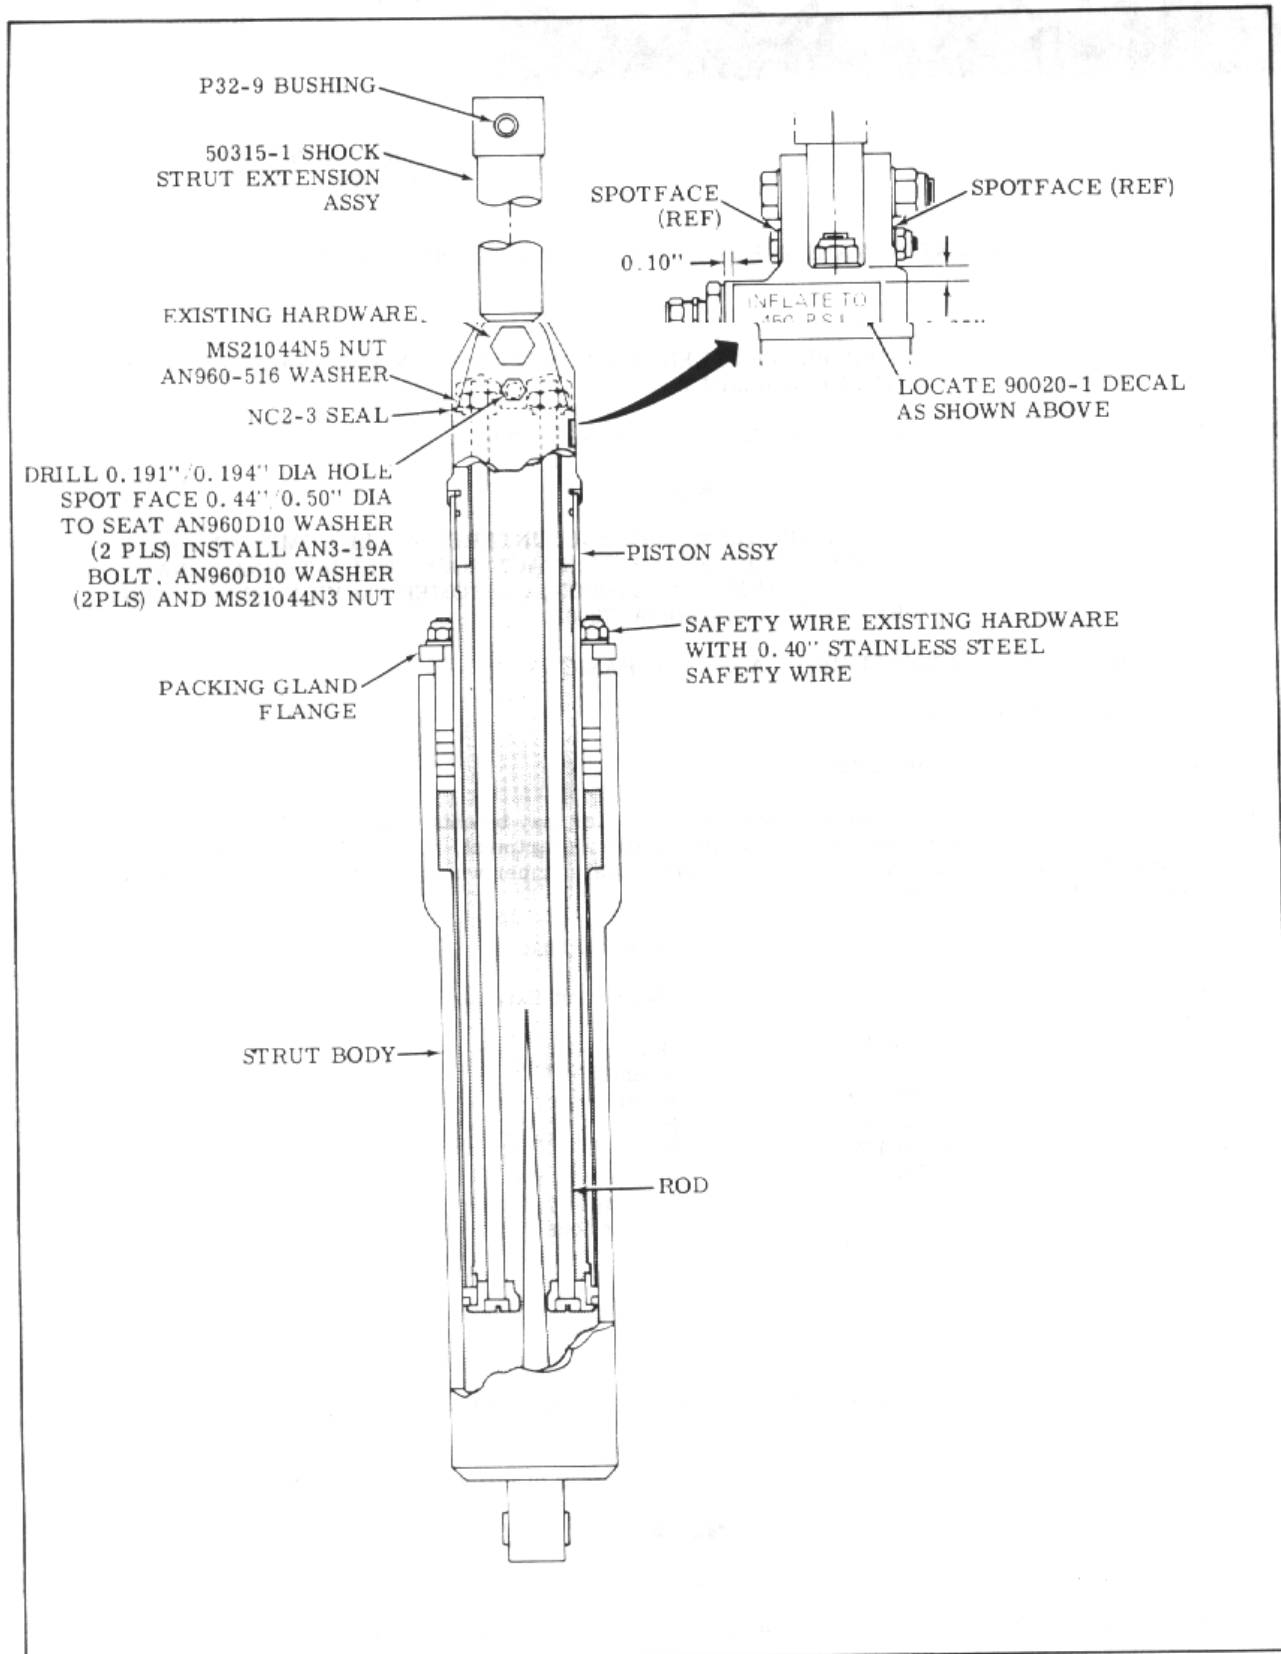
Figure 1.

**REASON FOR PUBLICATION:** To improve steering geometry and maintenance of tail wheel assembly.

5. After shock strut assembly has been deflated, remove filler plug and drain all fluid.
6. Modify the existing shock strut assembly as follows:
  - a. Remove lockwire and four (4) nuts on the studs that hold the packing gland flange in place (see Figure 1.).

- b. Remove the piston assembly from the strut body.
  - c. Remove and discard existing shock strut extension assembly and seals.
  - d. Install NC2-3 seal, AN960-516 washer and MS21044N5 nut (2 places) on existing rods see Figure 1.).

- e. Press fit P32-9 bushing in 50315-1 shock strut extension assembly (see Figure 1.).
  - f. Install 50315-1 shock strut extension assembly on existing shock strut assembly using existing hardware (see Figure 1.).

- g. Drill a 0.192 (+0.002, -0.001) inch diameter hole through shock strut cap and extension assembly (see Figure 1.).

- h. Spot face holes drilled in shock strut cap 0.47 ( $\pm$  0.03) inch diameter to seat AN960D10 washer (see Figure 1.).
- i. Install AN3-19A bolt, AN960D10 washer (2 places) and MS21044N3 nut (see Figure 1.).
- j. Reinstall piston assembly in strut body, tighten four (4) nuts just enough to prevent leakage past packing rings, and safety nuts with 0.040 inch diameter stainless steel safety wire.

- 7. With strut assembly in a vertical position and fully compressed, fill with MIL-H-5606 oil up to filler hole and install filler plug.
- 8. Inflate shock strut assembly to 450 psi air pressure and check for leaks.
- 9. Install 90020-1 decal (see Figure 1.).
- 10. Reinstall modified shock strut assembly on airplane using existing hardware.
