Rockwell service letter

Service Letter No. SL-AG-69
February 24, 1975

WING LEADING EDGE RIB RIVETS

EFFECTIVITY: MODEL S-2R, SERIAL NO'S 1416R THRU 2155R
5000R THRU 5010R.

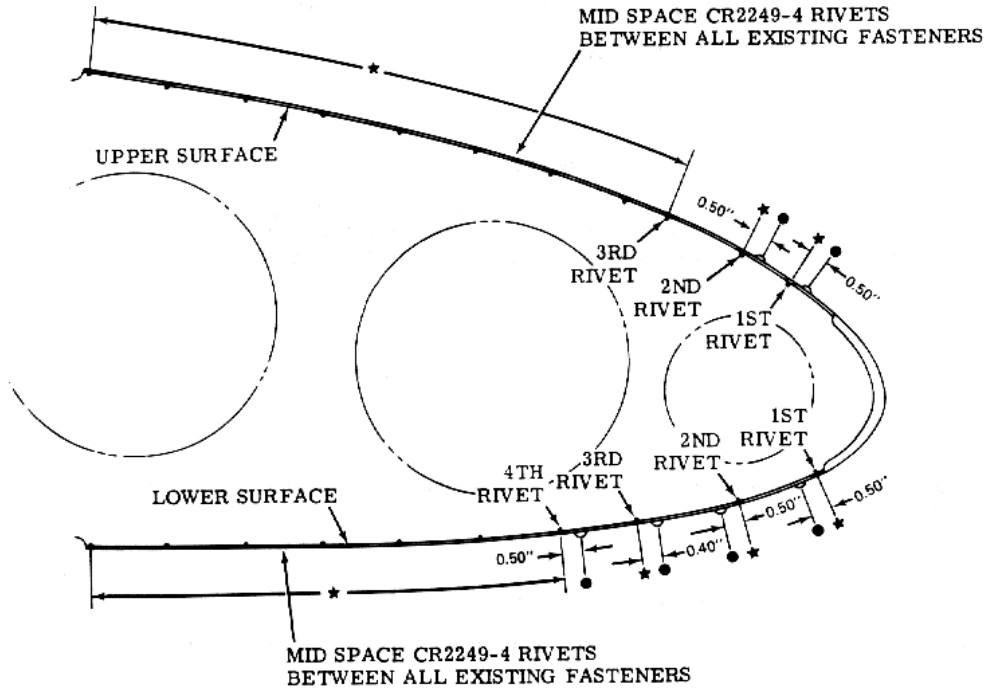
REASON FOR PUBLICATION: To provide instructions for replacing loose rivets and installing additional rivets on wing leading edge ribs.

TYPICAL FOR ALL
LEADING EDGE RIBS

- a. Remove and replace any loose existing rivets on wing leading edge ribs with CR2248-4 blind rivets (see Figure 1.).

- b. Using a No. 27 drill, drill and install CR2249-4 blind rivets, on upper and lower surface of wing leading edge ribs, mid-spaced between existing rivets (see Figure 1.).
- c. Using a No. 27 drill, drill and install additional CR2249-4 blind rivets on nose of wing leading edge ribs in area shown in Figure 1.
