SERVICE LETTER

No. SL-AG-118

Relocating Engine Control Hardware to Improve
Engine Response

S2R-H80

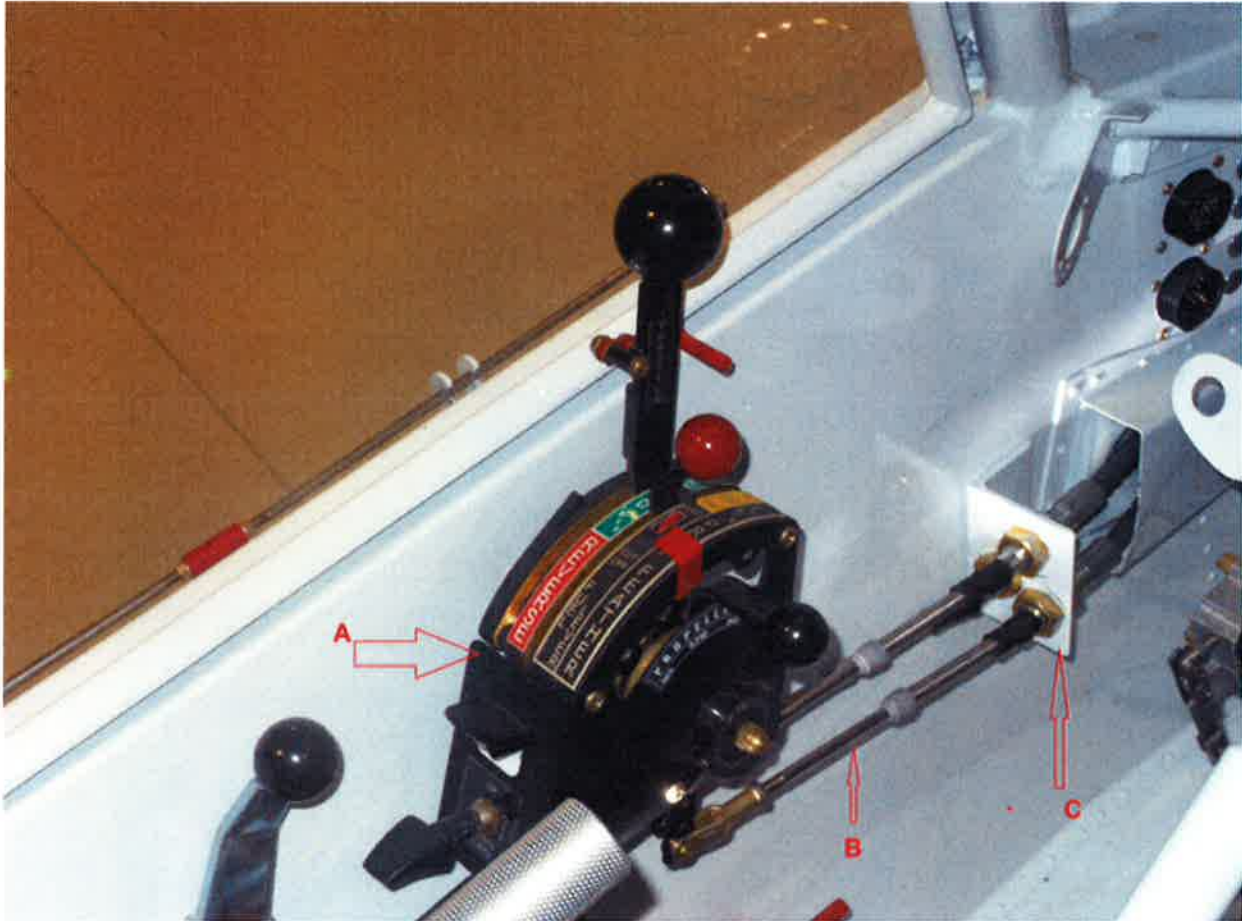
Figure 118-1

A Throttle Quadrant

B Control Cable

C Mounting Bracket

D Bracket Support Channel - Opposite side not shown here

- 7-3.1 DISCONNECT MOUNTING BRACKET C AND BRACKET SUPPORT CHANNEL D. RETAIN HARDWARE FOR LATER USE.

7-3.2 MODIFY BRACKET SUPPORT CHANNEL **D** BY DRILLING ONE HOLE CENTERED WITH EXISTING HOLES AND APPROXIMATELY 0.55 INCHES ABOVE THE TOP HOLE. Ø #10.

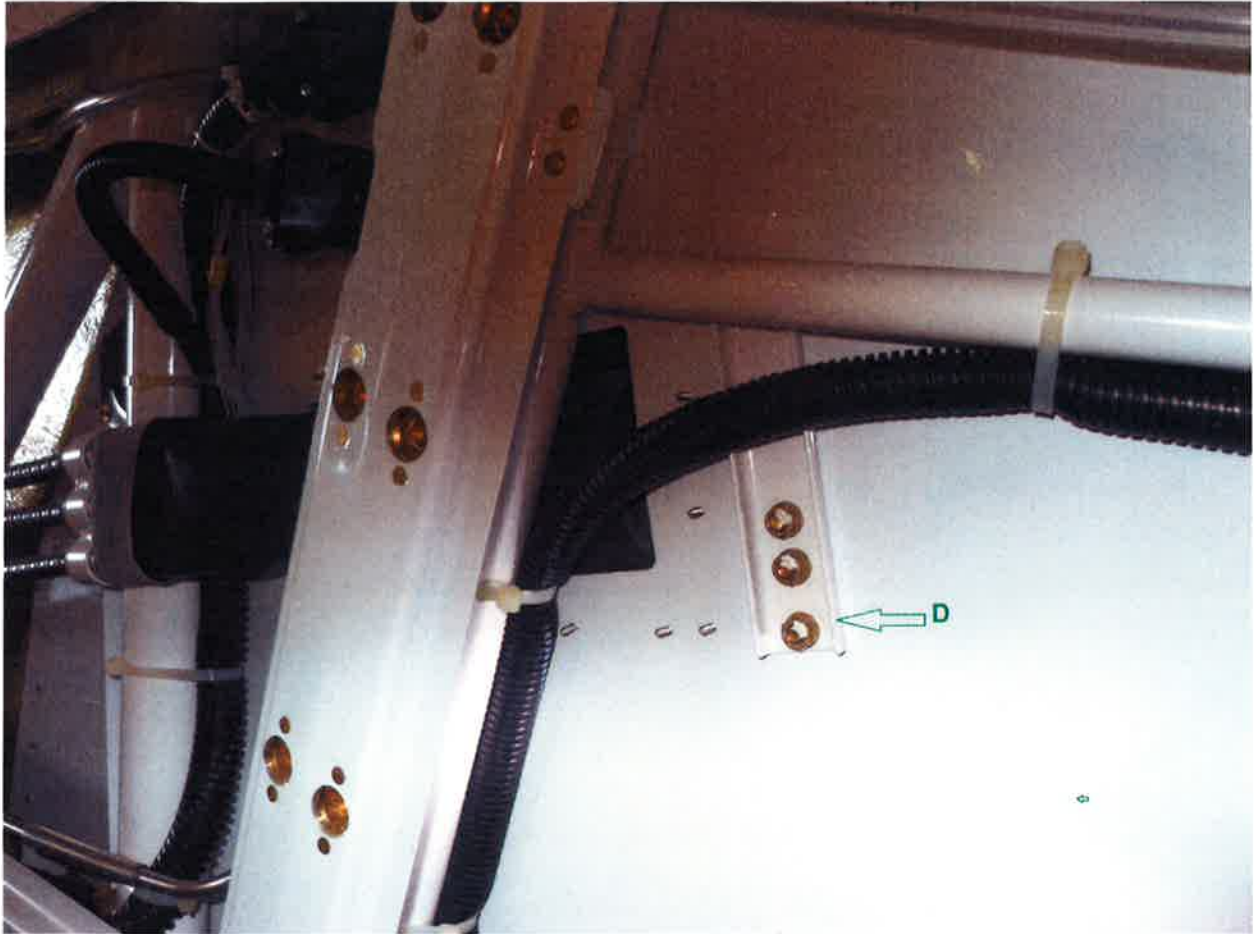
Figure 118-2

D Bracket Support Channel
