# Rockwell service bulletin No. SB-AG-2A

**Service Bulletin No. SB-AG-2A**  
**December 2, 1974**

INSPECTION OF RUDDER ASSEMBLY P/N 5-4030-41.

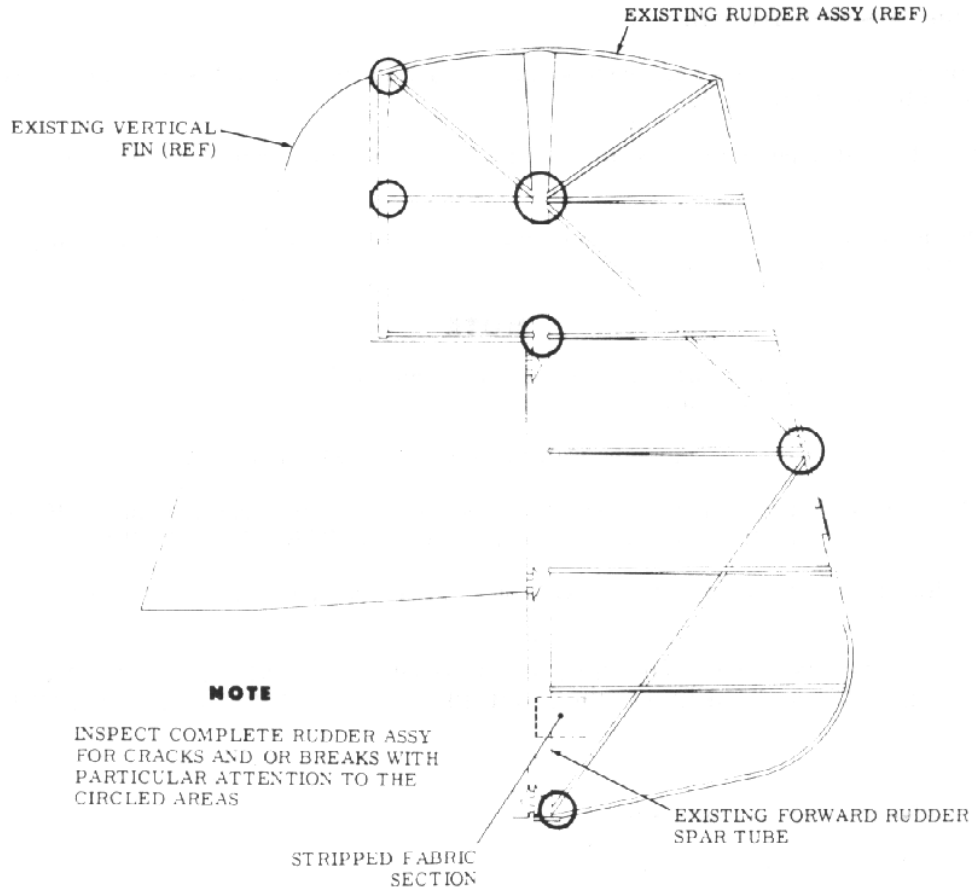
Figure 1.

- EFFECTIVITY:      PART I – MODEL S-2R, SERIAL NO'S 1416R THRU 1899R WITH RUDDER ASSEMBLY P/N 5-4030-41 INSTALLED.
- PART II – MODEL S-2R, SERIAL NO'S 1416R THRU 2029R WITH RUDDER ASSEMBLY P/N 5-4030-41 INSTALLED.
- COMPLIANCE:      SEE BELOW.
- APPROVAL:        FAA DER Approved
- PURPOSE:         Field repairs have revealed there were five rudder assemblies that were found to have tubing cracks or breaks. This Service Bulletin is being issued to aid the operator during inspection of the rudder assembly.

- a.      Remove rudder assembly from aircraft.
- b.      Remove approximately six(6) square inches of fabric and paint from both sides of the lower portion of rudder assembly (see Figure 1.).
- c.      In the center of the stripped fabric section, drill a ¼-inch diameter hole in one side only of the forward spar tube.
- d.      Measure the depth of the tube to the opposite inside wall and then using a precision caliper, measure the overall rudder spar tube diameter.

- a. Remove rudder assembly from airplane.
- b. Remove fabric from rudder assembly.
- c. Clean and inspect entire rudder assembly utilizing a dye penetrant test in accordance with FAA Advisory Circular AC 43.13-1 (see Figure 1.).
- d. If no cracks are found on aircraft Serial Numbers 1416R thru 1899R, rosette weld the ¼-inch inspection hole in accordance with FAA Advisory Circular AC 43.13-1 (Chapter 2, Page 26-1).
- e. If no cracks are found on aircraft Serial Numbers 1900R thru 2029R, proceed to step f.
- f. Repaint and recover rudder assembly with new fabric in accordance with FAA Advisory Circular AC 43.13-1.
- g. Install existing rudder assembly on aircraft.
- h. If cracks or breaks are found, discard existing rudder assembly and install 5-4030-87 rudder assembly.
- i. Fill out and mail compliance card.
