Service Letter No. SL-AG-96  
1 July, 1982

## FUSELAGE UPPER LONGERON INSPECTION

**MODELS AFFECTED:** S2R-R1820, S/N R1820-001 thru R1820-031

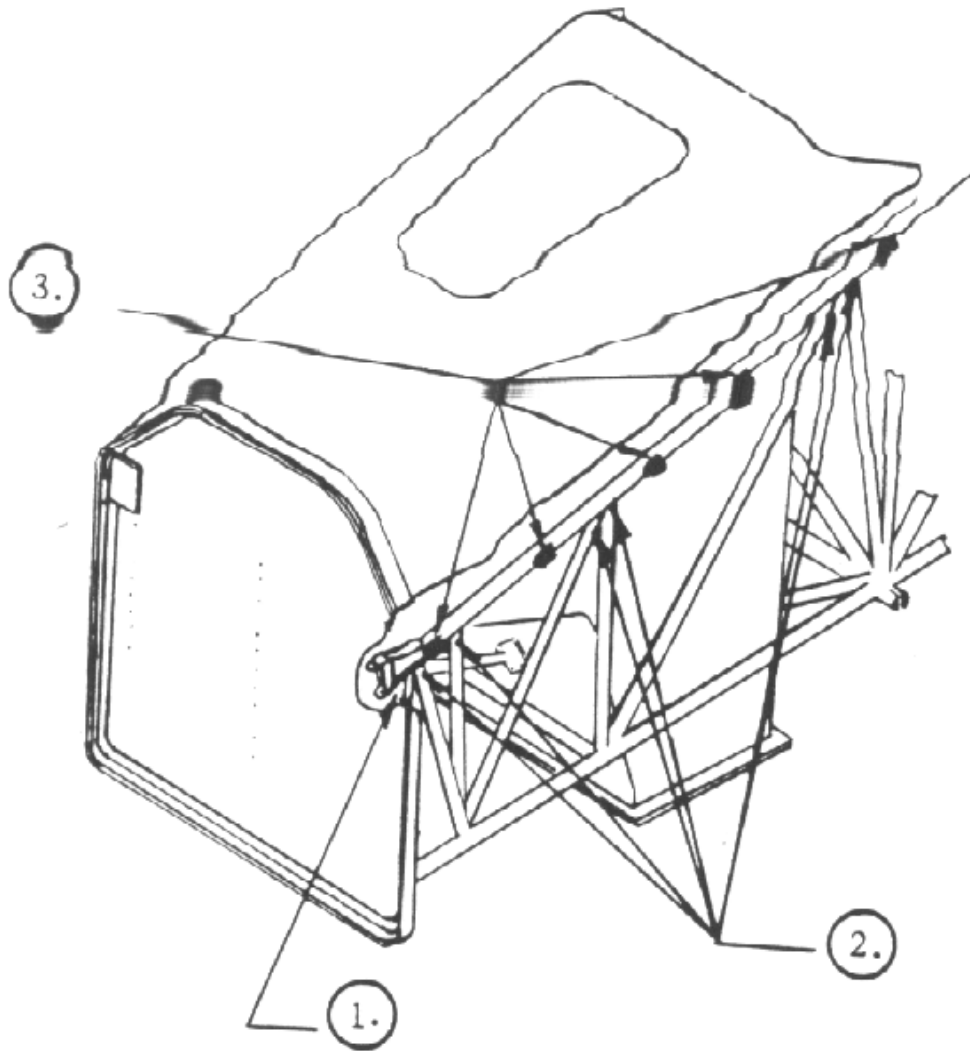
Figure 1.

**REASON FOR PUBLICATION:** There has been one report of the fuselage upper longerons being cracked through. This service letter is being issued to provide for inspection of the Fuselage Upper Longerons for possible fatigue cracks.

- 1 Remove the fuselage side skin located between the wing upper surface and the hopper. This will provide access to the upper longeron from the firewall to the cockpit.
- 2 Visually inspect the longeron paying particular attention to: (See Fig 1.)

- a. Area around the upper engine mount attach points
  - b. Each vertical and diagonal tube intersection at the upper longeron
  - c. Each hopper attachment bracket
- 3 If no cracks are found, return airplane to service.
  - 4 If cracks are found, PRIOR TO NEXT FLIGHT, contact for corrective action:

- ①. UPPER ENGINE MOUNT ATTACH POINT
- ②. VERTICAL AND DIAGONAL TUBE INTERSECTION
- ③. HOPPER ATTACHMENT BRACKETS
