THRUSH AIRCRAFT, INC.

SERVICE LETTER

No. SL-AG-113

Flap Light Nuts Rubbing Flaps

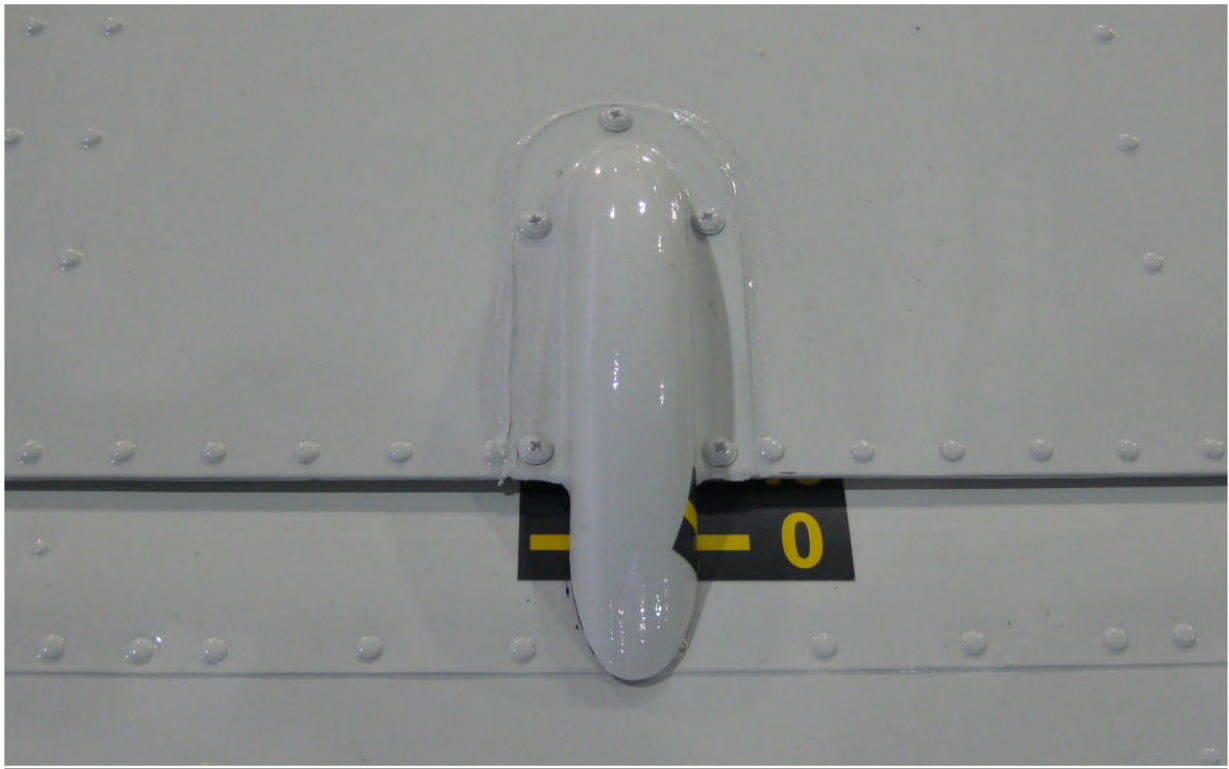
Figure 113-1: Flap Light Installation

Figure 113-1 shows the flap light installation on the left wing of the aircraft. Lower the flaps to the full down position and inspect the flap skin aft of the flap light for scratches.

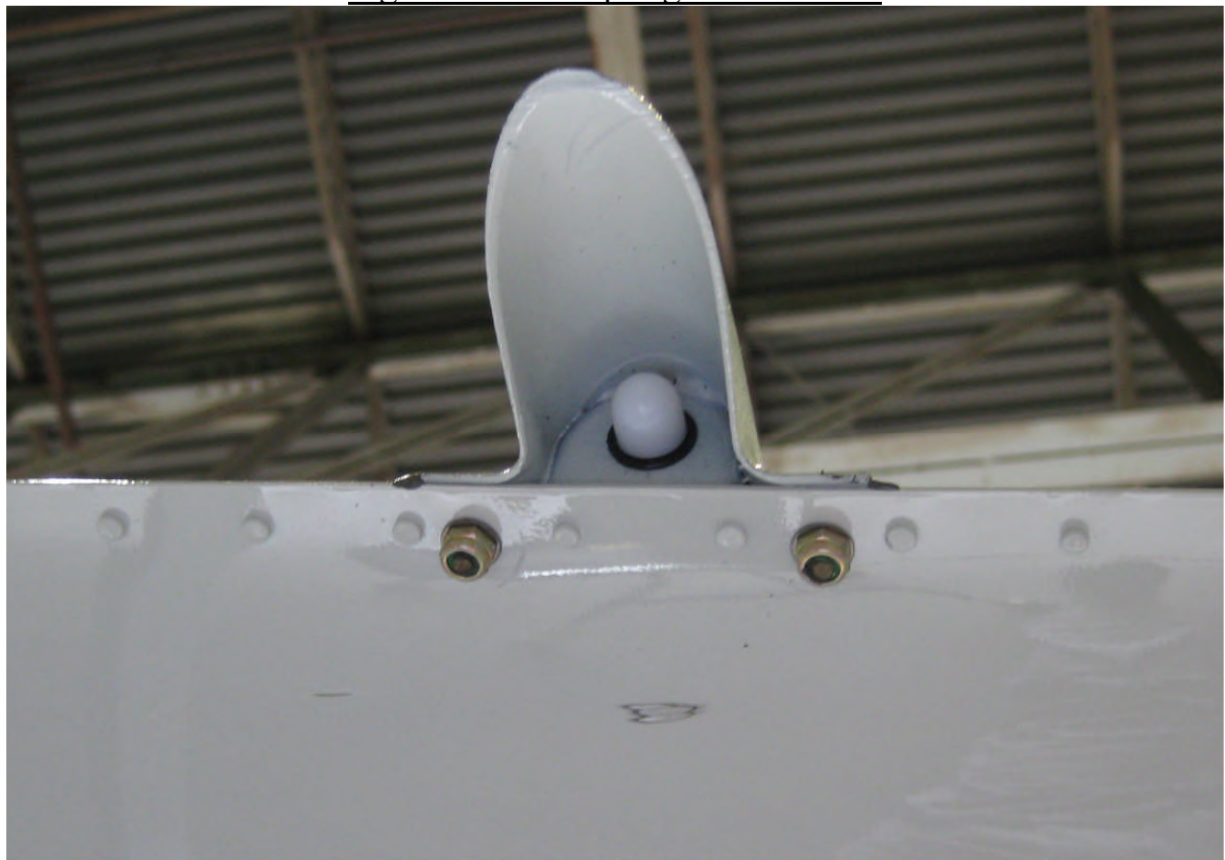
Figure 113-2: Nuts on Trailing Edge of Flap Cove

The light that illuminates the wing flap position markings on the left wing is attached to the wing with 5 screws and nuts, as well as sealer to keep rain out. The two aft-most screws are through the flap cove trailing edge and the nut protrudes down approximately one-fourth inch on the under side.

Due to manufacturing variation, the nuts occasionally contact the flap nose skin, causing scratches when the flap moves. This problem is solved before new airplanes leave the factory, but it can happen in service as the airplane accumulates flight hours.

If scratches are found, the two aft attach screws and nuts holding the Flap Light to the wing (see Figure 113-2) need to be changed or modified to eliminate the interference with the flap. There are several ways to remedy this problem:

- The easiest method is to replace the two aft screws with AN526-632-5 screws and replace the AN365-632 nuts with AN364-632 nuts. These are accessible with the flap in the down position. If slightly more clearance is needed, the AN960-6 washers can be replaced with AN960-6L washers, or the washers can be deleted.

- If this does not provide sufficient clearance, the direction of the screw should be reversed; that is, it should be installed from the bottom.
- If neither of these methods provides sufficient clearance, the aft two screws and nuts attaching the flap light assembly to the wing can be left out entirely. The remaining three fasteners are more than sufficient to hold the flap light securely in position. In this case the bead of sealant around the flap light cover should be inspected at every 100 hour inspection to be sure it is intact. If the sealant cracks or separates, remove the old sealant and replace with new sealant. Fuel tank sealant is used at the factory.
